# Tampa Bay Water Recovery Assessment: Final Report of Findings

Final Report  
Consolidated Water Use Permit  
September 29, 2020

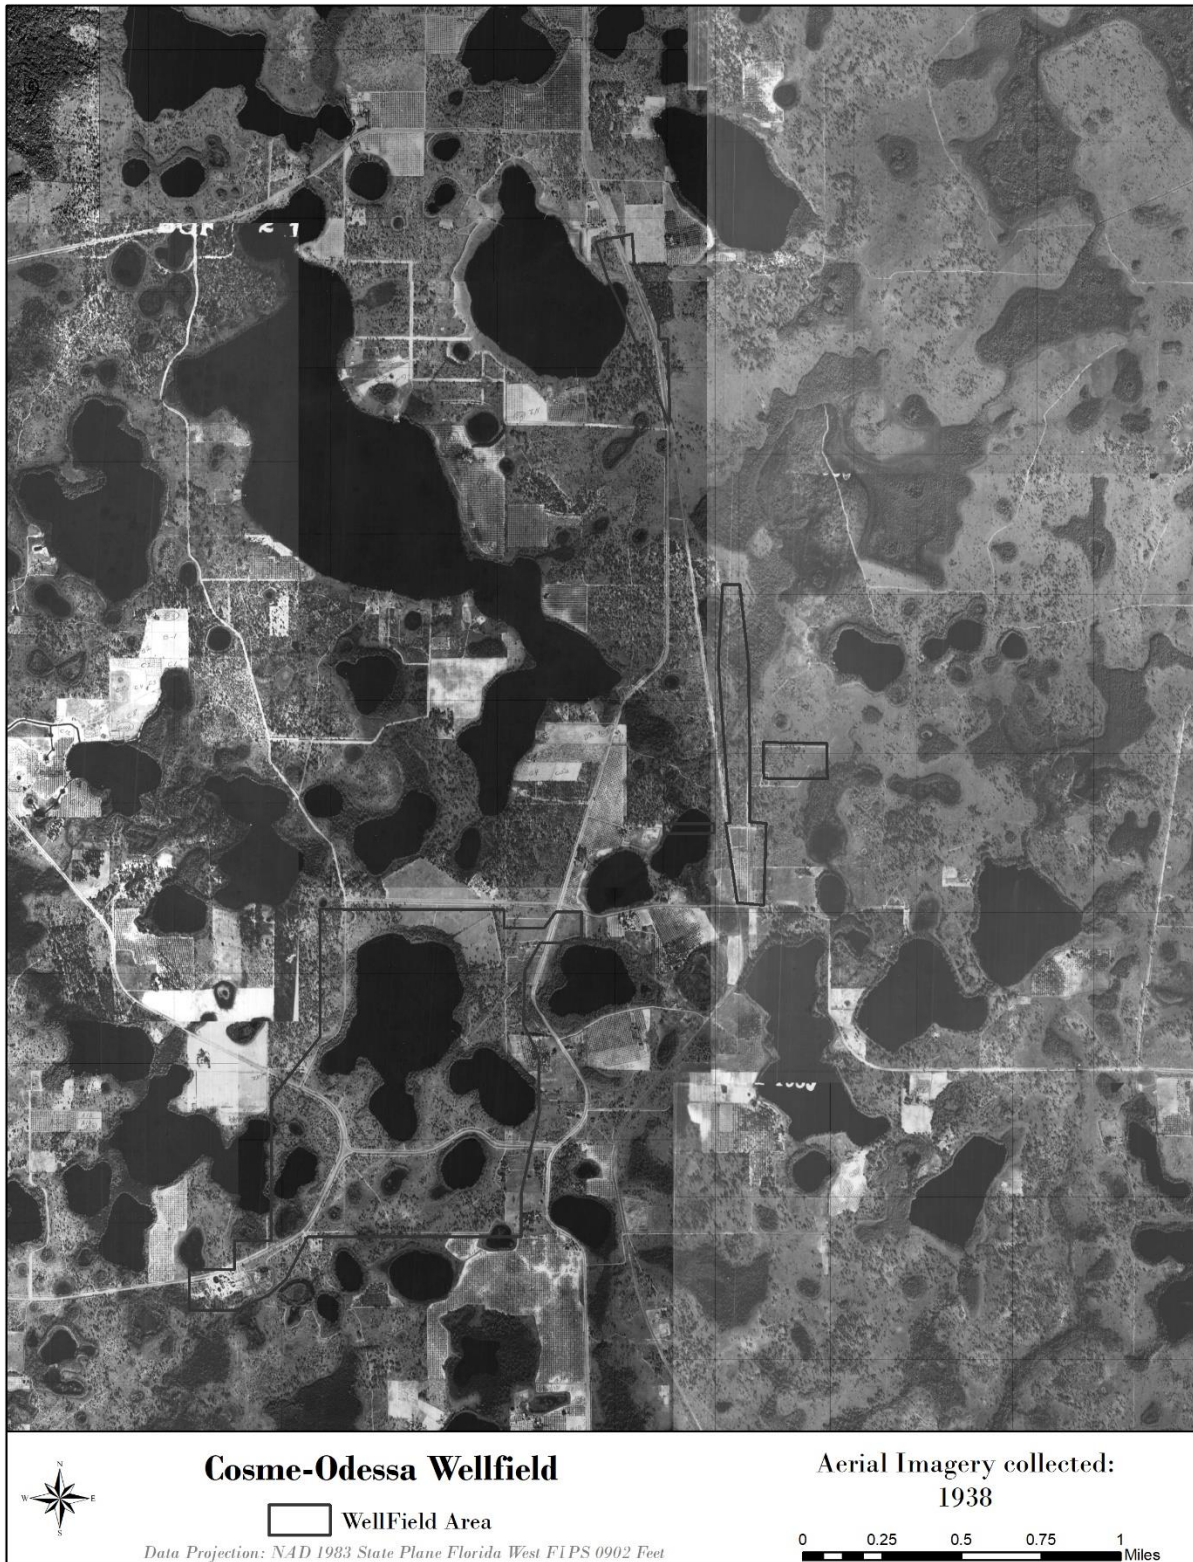
**Figure 3.3: Aerial Photograph of the Cosme-Odessa Wellfield Area from 1938**

wellfield area (Figure 3.3) showed few homes in the Cosme-Odesa area in the late 1930's and an abundance of citrus groves (Leggette, Brashears & Graham, 1995). The land use had shifted to primarily agriculture by the late 1950's and the wellfield pumping rate was almost 20 mgd by 1962. Lower water levels in some area lakes were noted by the City and area residents beginning in the 1950's (Southwest Florida Water Management District, 1996a) and these declines in lake water levels became more pronounced following the very high rainfall years of 1959-1960 (Southwest Florida Water Management District, 1984a). Lower lake water levels were likely a combination of drawdown from wellfield pumping, land use and drainage changes related to citrus groves and home construction around the lakes combined with several years of substantially below-average rainfall. Engineering studies conducted for the City in 1959 and 1960 indicated that large-scale increases in pumping at the Cosme-Odesa Wellfield would potentially cause salt-water intrusion problems in the area (Leggette, Brashears & Graham, 1966), the very problem that prompted the City to develop this wellfield. In response to the growing water demand of City customers, the risk of salt-water intrusion, and an awareness of pumping-related impacts at the Cosme-Odesa Wellfield, the City began developing the Section 21 Wellfield in 1961 as their next potable water supply source.

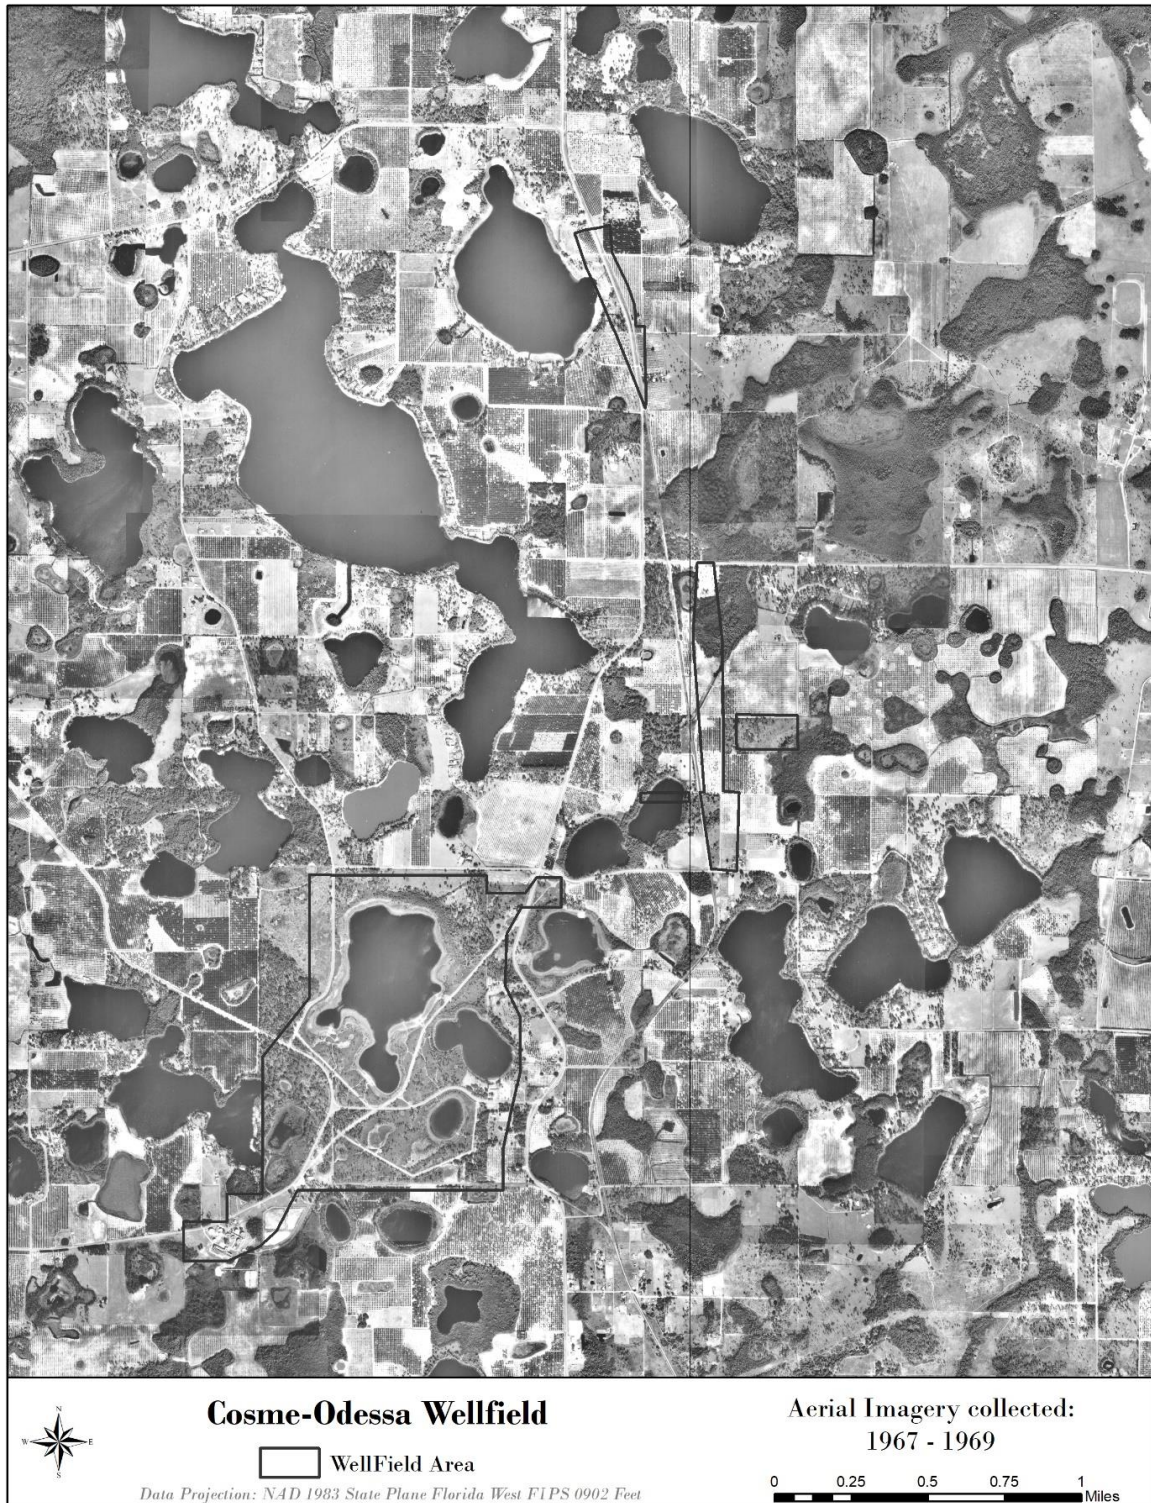
**Figure 3.4: Aerial Photograph of the Cosme-Odessa Wellfield Area from 1967 - 1969**

Citrus acreage in the wellfield area continued to increase and home construction continued; both are visible in aerial photography from 1967. Numerous homes surrounding the lakes are shown in Figure 3.4. The land in northwest Hillsborough County where the Cosme-Odesa Wellfield is located has remained mostly rural although much of the former agricultural land use has transitioned to residential use (Figure 3.5). Homes have been constructed surrounding most of the lakes in the region with small residential developments along county roads. Citrus production has largely left the area with only a few groves remaining; small blueberry farms and plant nurseries have moved into the community.

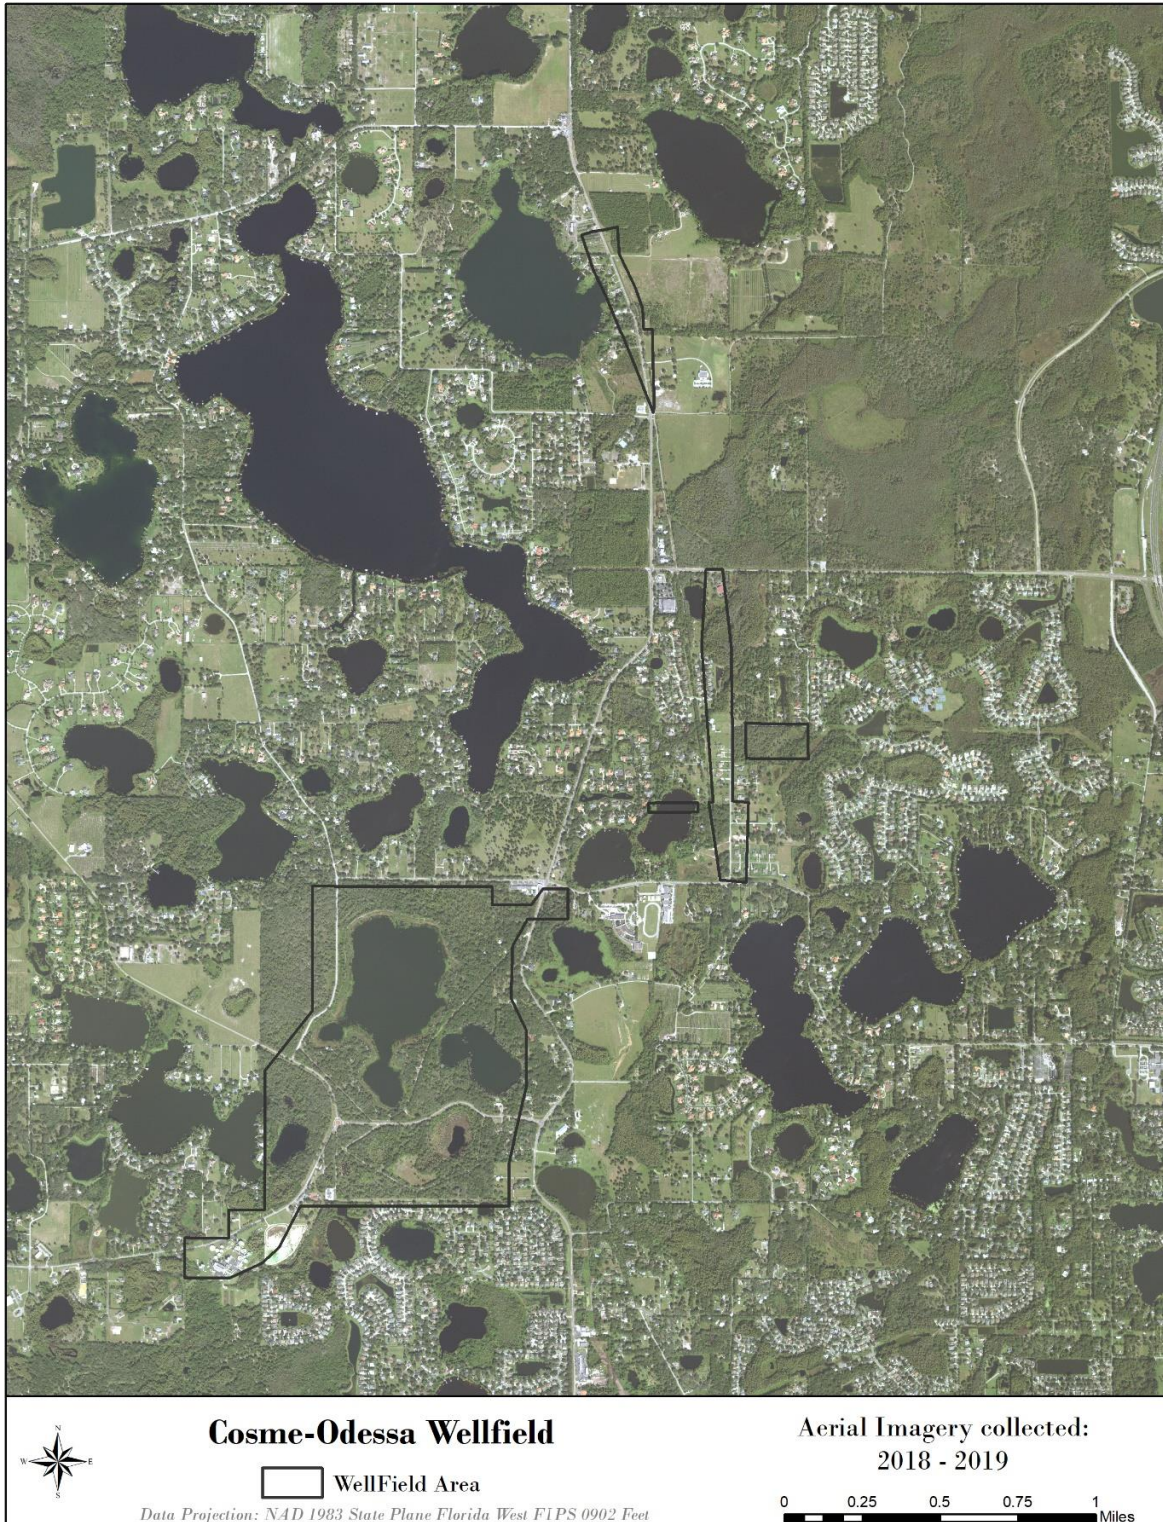
**Figure 3.5: Aerial Photograph of the Cosme-Odessa Wellfield Area from 2018 - 2019**

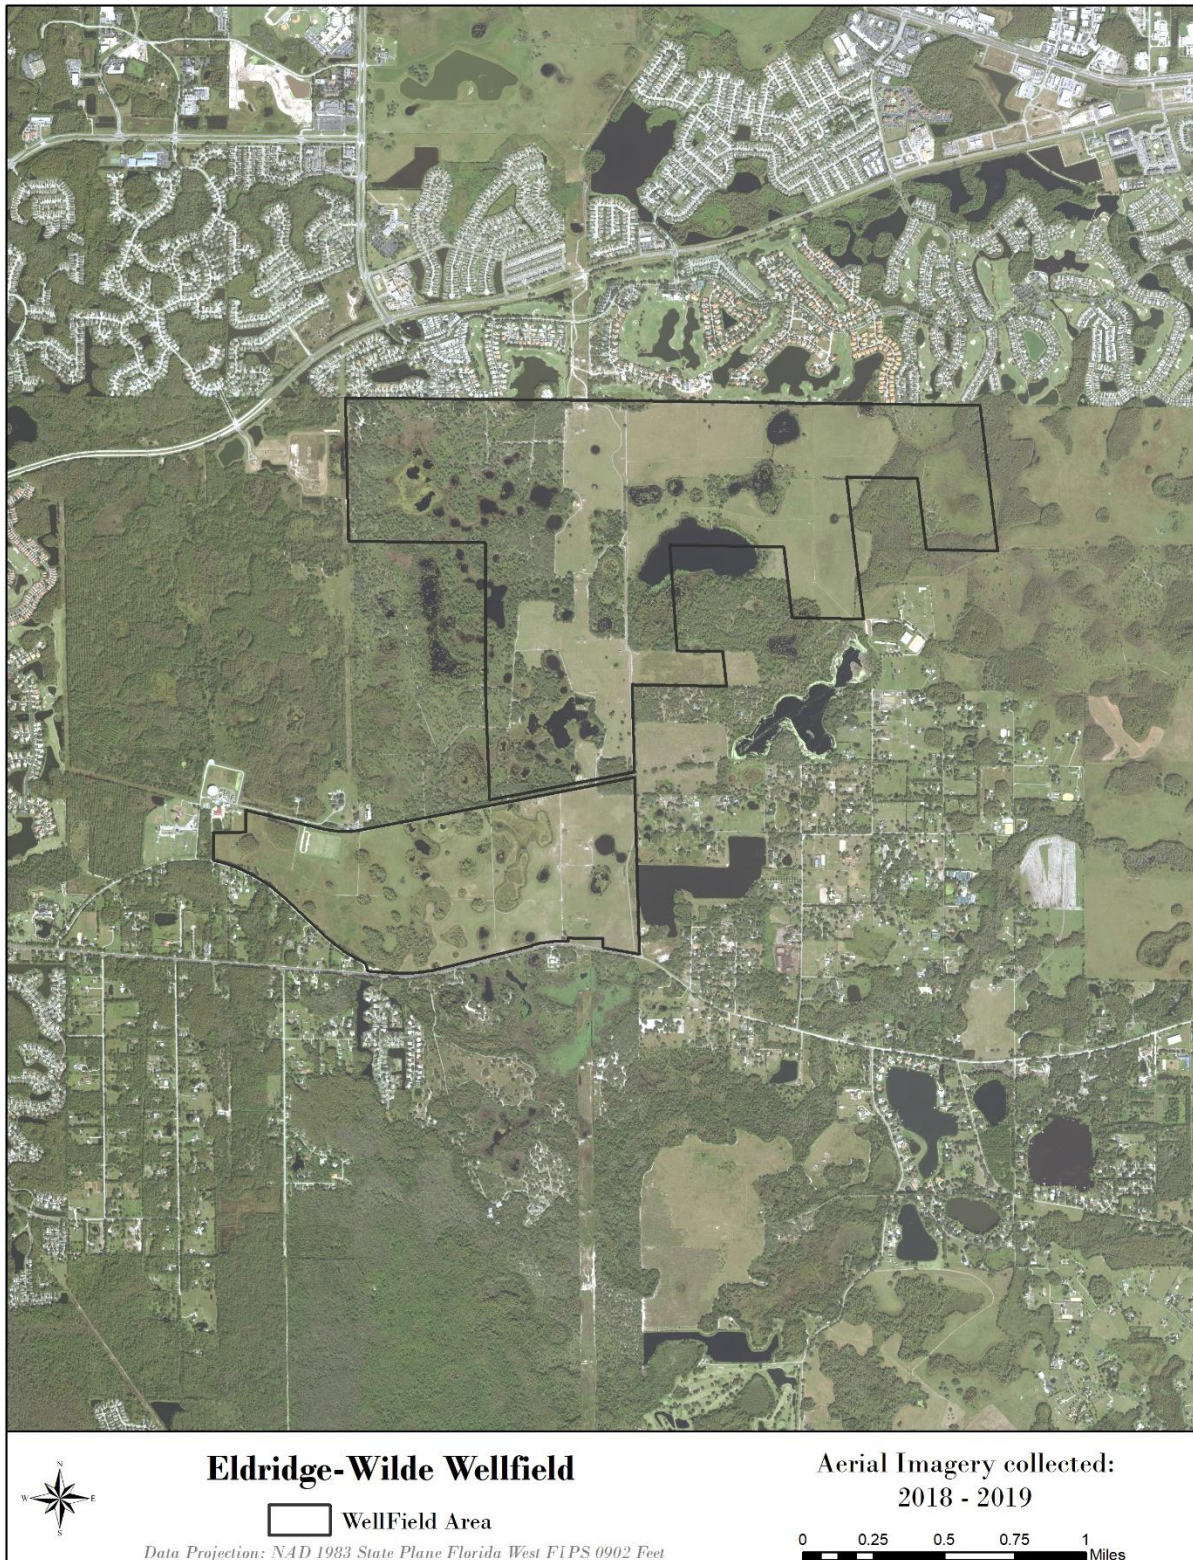
**Figure 3.8: Aerial Photograph of the Eldridge-Wilde Wellfield Area from 2018 – 2019**

The Eldridge-Wilde Wellfield has remained in a natural setting since development in the 1950's with cattle ranching operations on-site until recent years. The land surrounding the wellfield in Hillsborough County has remained rural with low-density residential land use. The largest residential development in the wellfield area is the Trinity Development, located on the north property boundary of the wellfield in Pasco County (Figure 3.8). Initial construction of this development began between 1990 and 1995; the residential areas on the northern boundary of the wellfield were essentially completed by 2008. The Trinity community continues to develop to the present time with the development of East Trinity and commercial infill throughout the community. This community has experienced significant flooding in recent years with Pasco County and the District continuing to work on solutions to manage flooding through the Duck Slough system which runs through the middle of the Trinity Development.

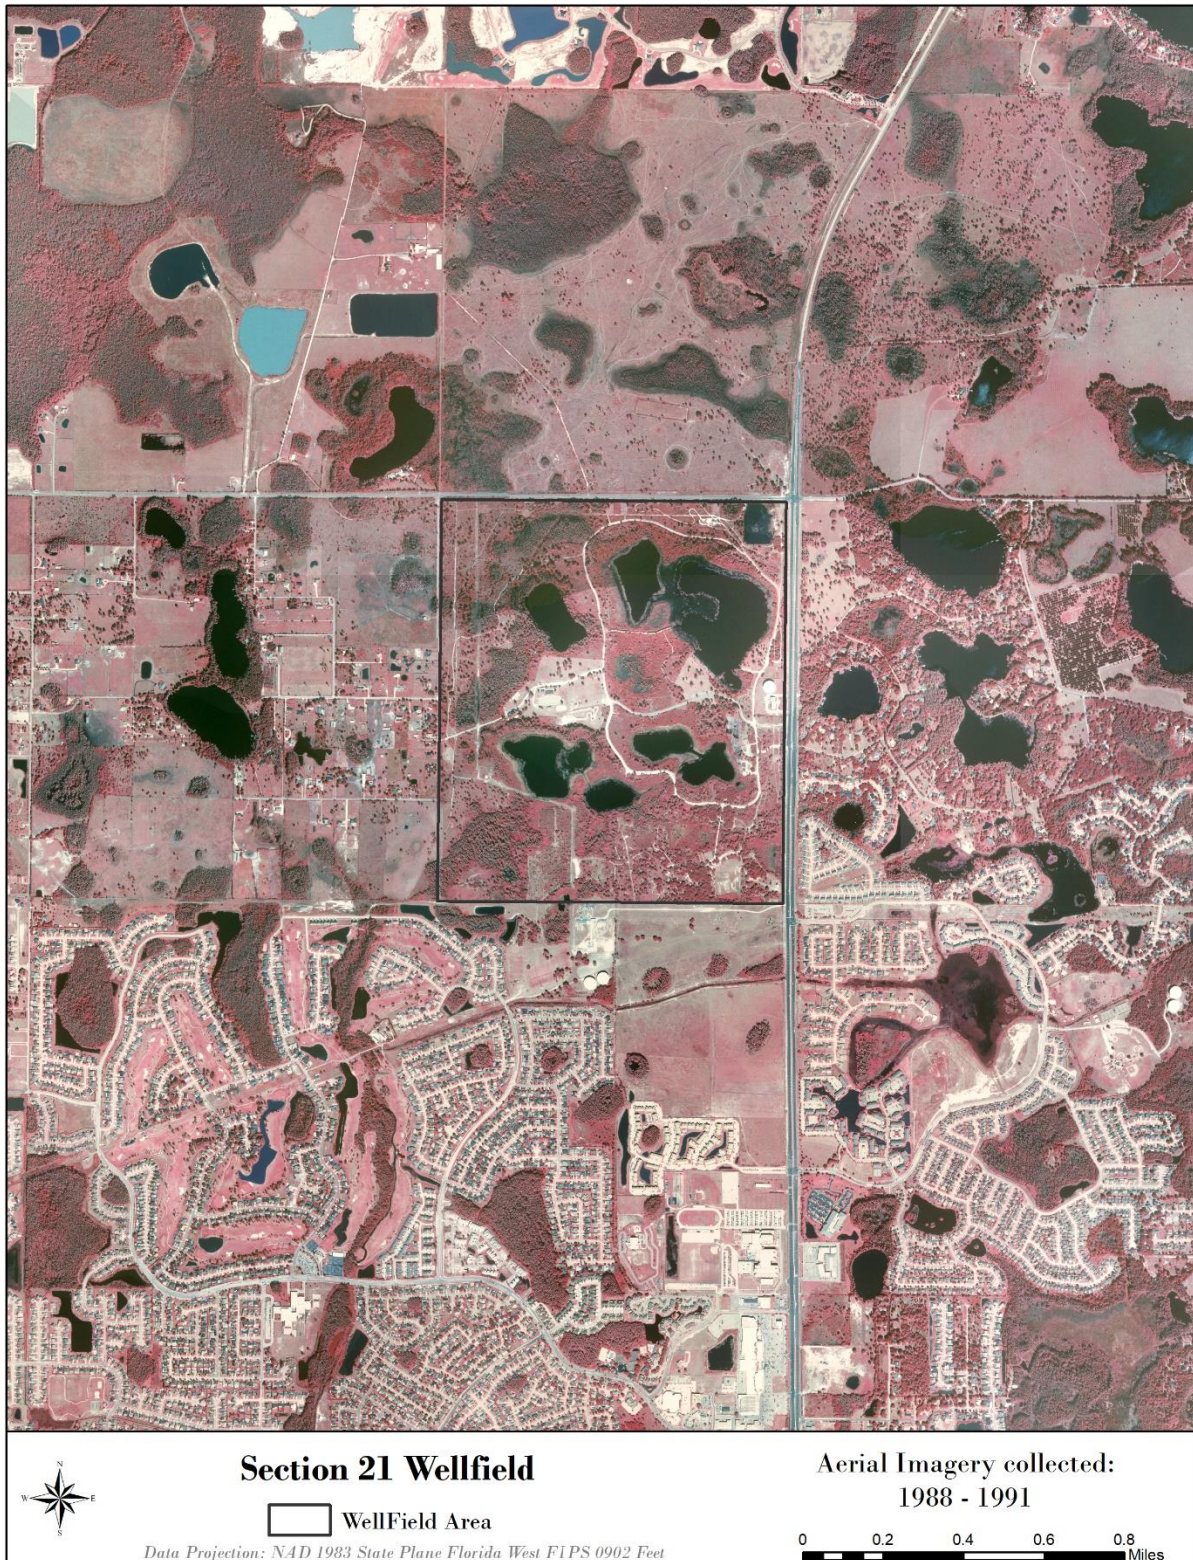
**Figure 3.11: Aerial Photograph of the Section 21 Wellfield Area from 1988 – 1991**

Other factors associated with lowered lake and wetland water levels over time are development and drainage modifications in a rapidly urbanizing area (Leggette, Brashears & Graham, 1995). Notable landscape changes near the Section 21 Wellfield include the widening of Dale Mabry Highway on the east border of the property and Van Dyke Road on the north border of the property. These and other roads have caused an unquantified change in surface water flow to Starvation Lake and other features on the wellfield. The residential and commercial development in the surrounding area and roads adjacent to the wellfield are part of stormwater management systems which have changed the flow of surface water to the wellfield property. The largest stormwater management feature near the wellfield is the Interceptor Canal which was constructed by Hillsborough County in the mid-1960's. The canal extends from Lake Heather to Brushy Creek to allow the water level in interconnected upstream lakes to flow out of the area during high rainfall events. This feature was constructed to alleviate flooding of lakefront homeowners to the east and northeast of the wellfield. The District concluded that the canal has a minimal direct effect on Starvation Lake within the wellfield (Southwest Florida Water Management District, 1996a); however, the potential impacts to other environmental features has not been quantified. The canal is visible in Figure 3.10 and an aerial photograph from the late 1980's shows that urban development had covered the landscape south and east of the wellfield and a new development was under construction to the north of the property Figure 3.11.

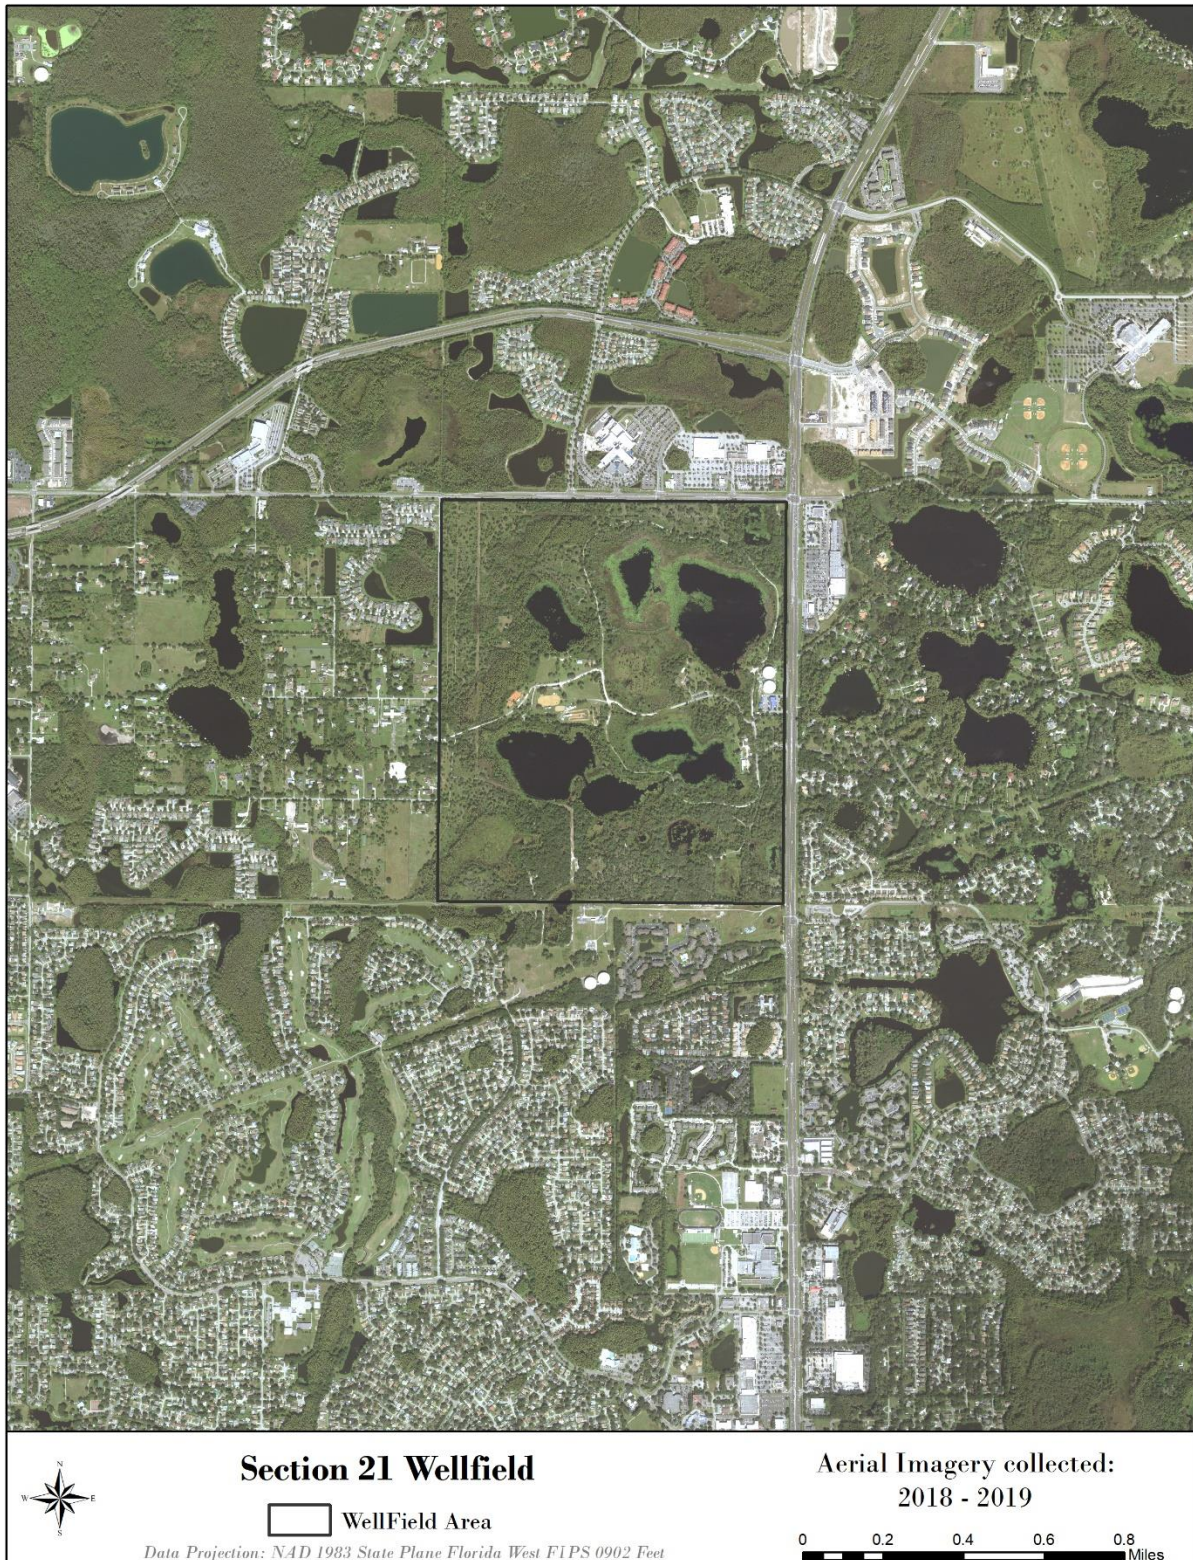
**Figure 3.12: Aerial Photograph of the Section 21 Wellfield Area from 2018 – 2019.**

Tampa Bay Water modified four of the six active production wells in 2003 and 2004 by deepening the total depth of the wells into the Avon Park Formation (between 663 and 700 feet below land surface). The production casings of three of these wells were extended to depths of approximately 200 feet below land surface. The production casings in wells S21-8 and S21-10 could not be deepened due to physical restrictions in these two wells and S21-10 could not be deepened due to other well construction difficulties (Leggette, Brashears & Graham, 2005). These well modifications were made to increase the well productivity and decrease the flow into the wells from the shallow zones within the aquifer. These changes were expected to result in less pumping-related impact to the lakes and wetlands on the wellfield property and reduce the probability of bacteriological issues in the production wells. The pumping capacities increased in the four wells that were deepened and surface water levels have been higher since the wells were returned to service in 2005. It is unknown what portion of the improved lake and wetland water levels on the wellfield are due to the well modifications and what portion is due to the reduction in wellfield pumping that began in 2005. A recent aerial photograph of the wellfield area (Figure 3.12) shows that dense urban development now covers the area with residential developments, retail, and support infrastructure (schools, hospitals, and sports fields).

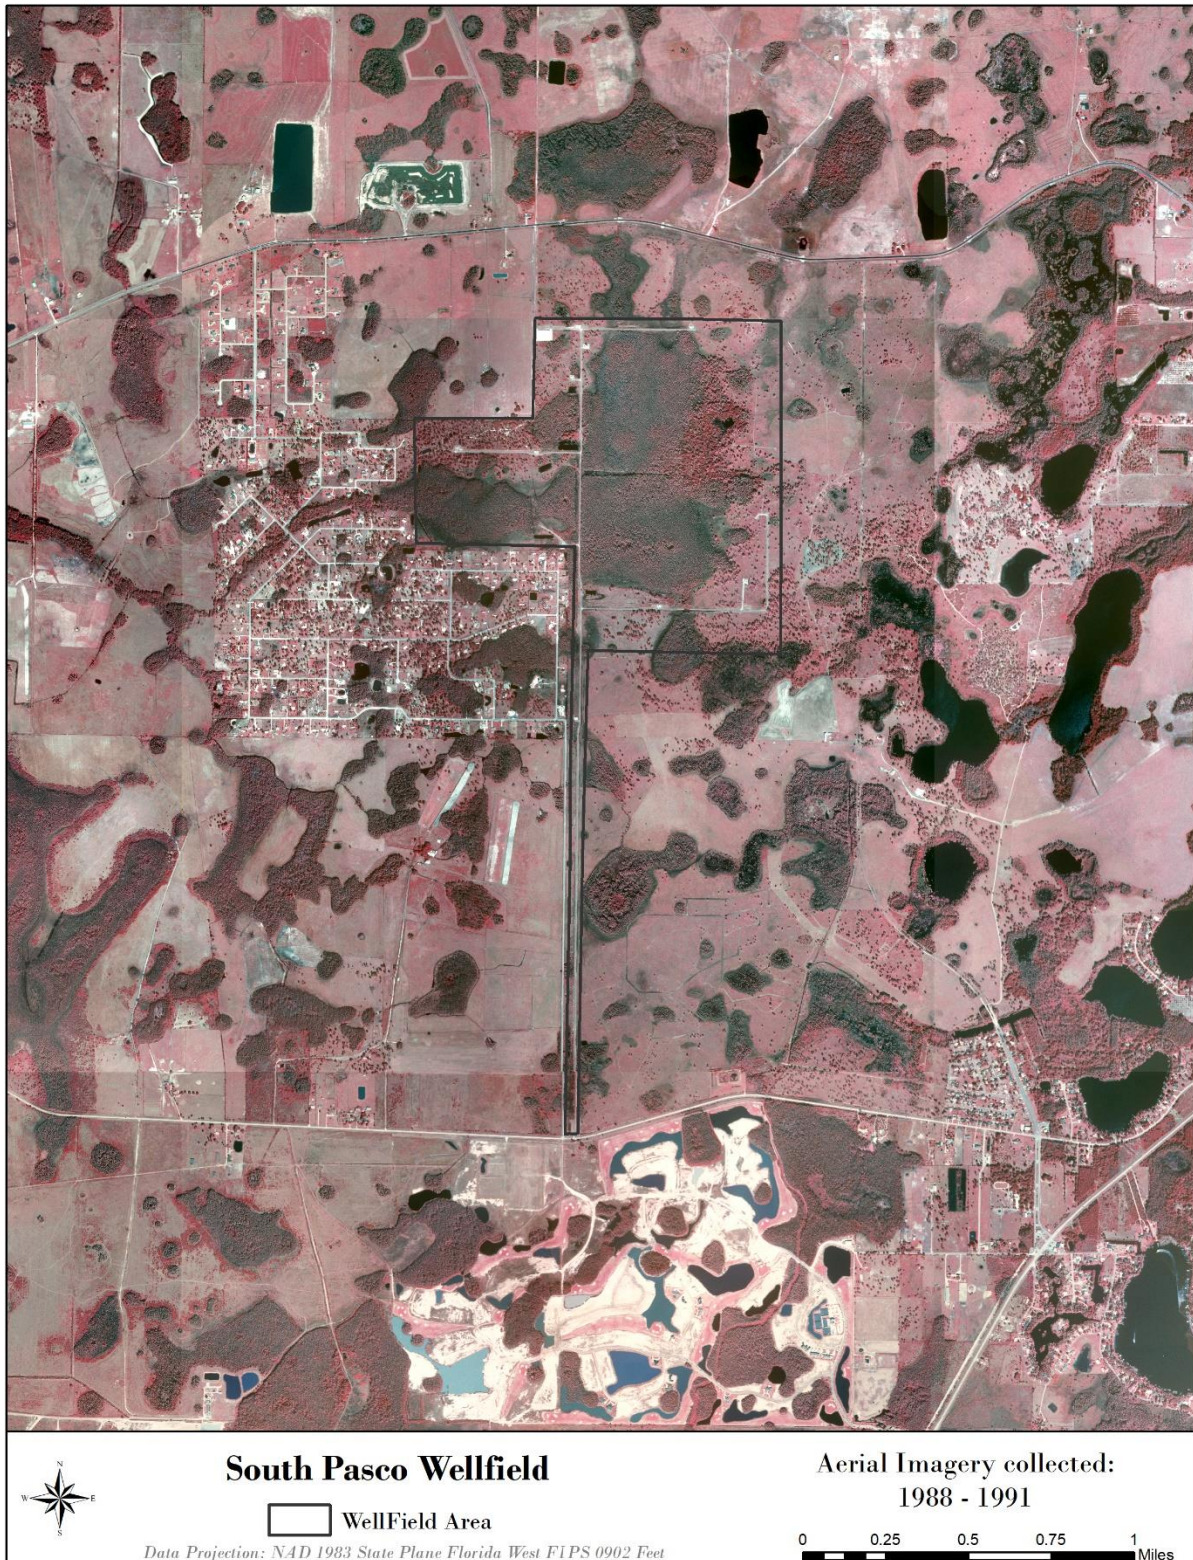
**Figure 3.14: Aerial Photograph of the South Pasco Wellfield Area from 1988 – 1991**

The South Pasco Wellfield was in a rural setting when the wellfield was developed by the City. The first development in the immediate area of the wellfield was the Sierra Pines neighborhood located immediately west of the property. Historical aerial photography shows that the roads for this single-family home neighborhood were being constructed in 1974 which was the first of five consecutive years where the wellfield pumped an average of approximately 15 to 16 mgd. Aerial photography shows that this subdivision was built-out by 1985. Additionally, another subdivision, Meadowbrook Estates located north of Sierra Pines and south of State Road 54, was developed. These developments can be seen in the aerial photograph from 1998 (Figure 3.14) along with a large residential development (Cheval) under construction south of Lutz-Lake Fern Road. The land immediately south of the wellfield began developing in late 1998 with initial construction of Heritage Harbor and Villa Rosa in 1999. Both subdivisions were complete by 2004. Development on the east side of the wellfield began in 2001 with the excavation of a large oblong pond. This land sat idle until 2012 when construction began on the Long Lake Ranch development. By 2017, construction was complete at the Long Lake Ranch development and the extension of Sun Lake Boulevard was complete, now stretching from Van Dyke Road to and across State Road 54. The extension of this road lies on the eastern property boundary of the South Pasco Wellfield. These developments and features can be seen in the aerial photograph from 2018 – 2019 (Figure 3.15). The property to the north of the wellfield was cleared during 2019 and 2020 and will likely become commercial property along State Road 54.

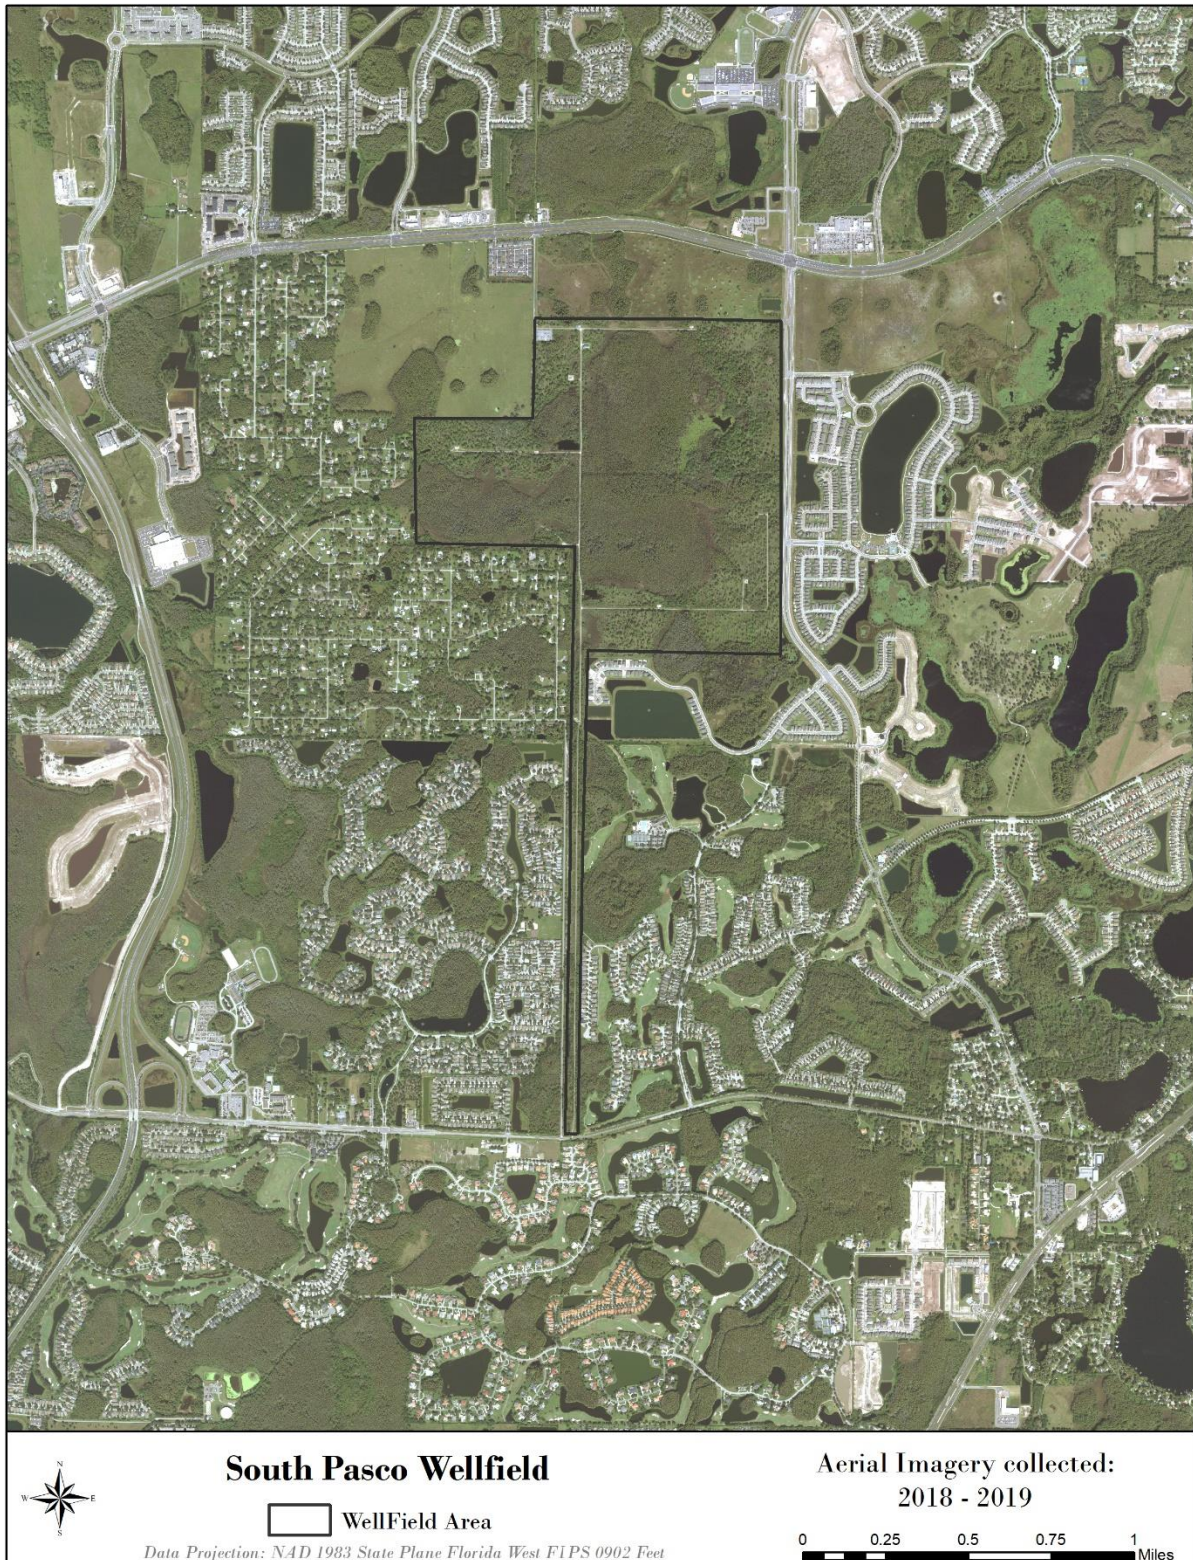
**Figure 3.15: Aerial Photograph of the South Pasco Wellfield Area from 2018 – 2019**

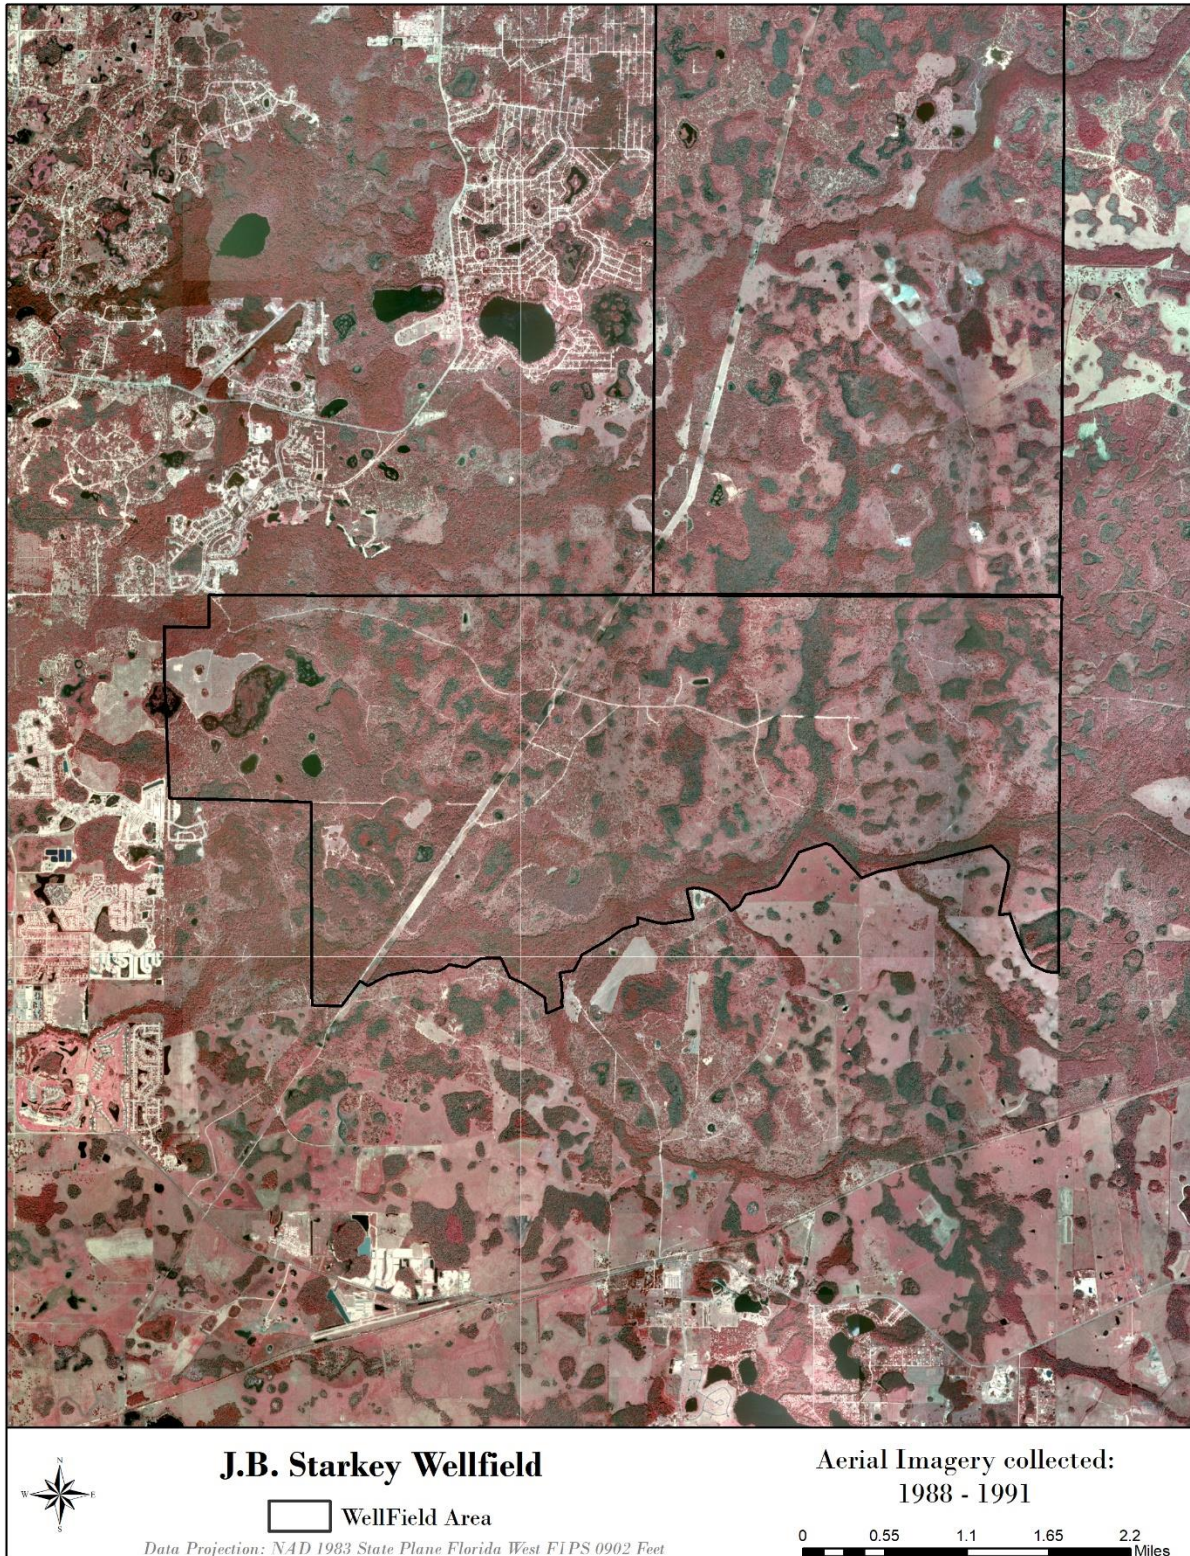
**Figure 3.17: Aerial Photograph of the Starkey Wellfield Area from 1988 – 1991**

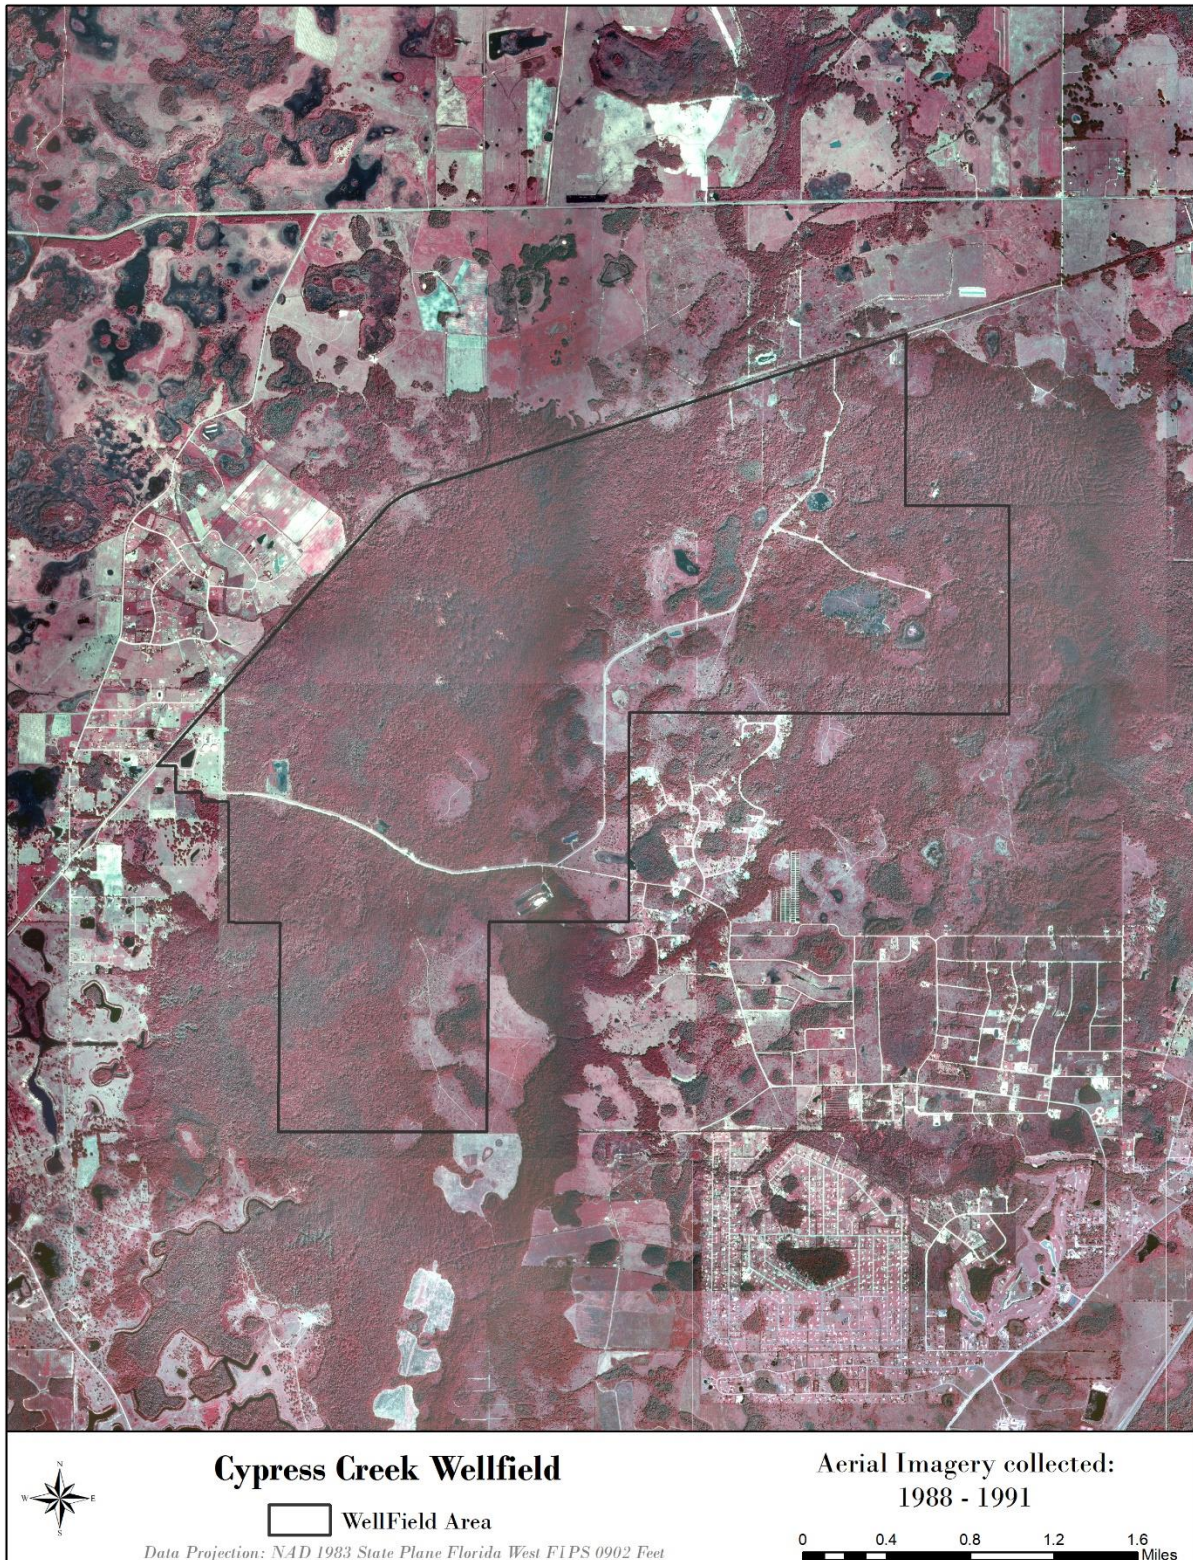
**Figure 3.20: Aerial Photograph of the Cypress Creek Wellfield Area from 1988 – 1991**

Homes in the Quail Hollow subdivision were constructed after 1974 and continued through 1995, including some along Quail Run Drive, immediately south of the wellfield property boundary. These homes were constructed with septic tank systems which exist to the present time. This development is visible to the southeast of the wellfield property in the aerial photograph from 1988 – 1989 (Figure 3.20) along with low-density residential development to the west of the wellfield.
