# Tampa Bay Water Recovery Assessment: Final Report of Findings

Final Report  
Consolidated Water Use Permit  
September 29, 2020

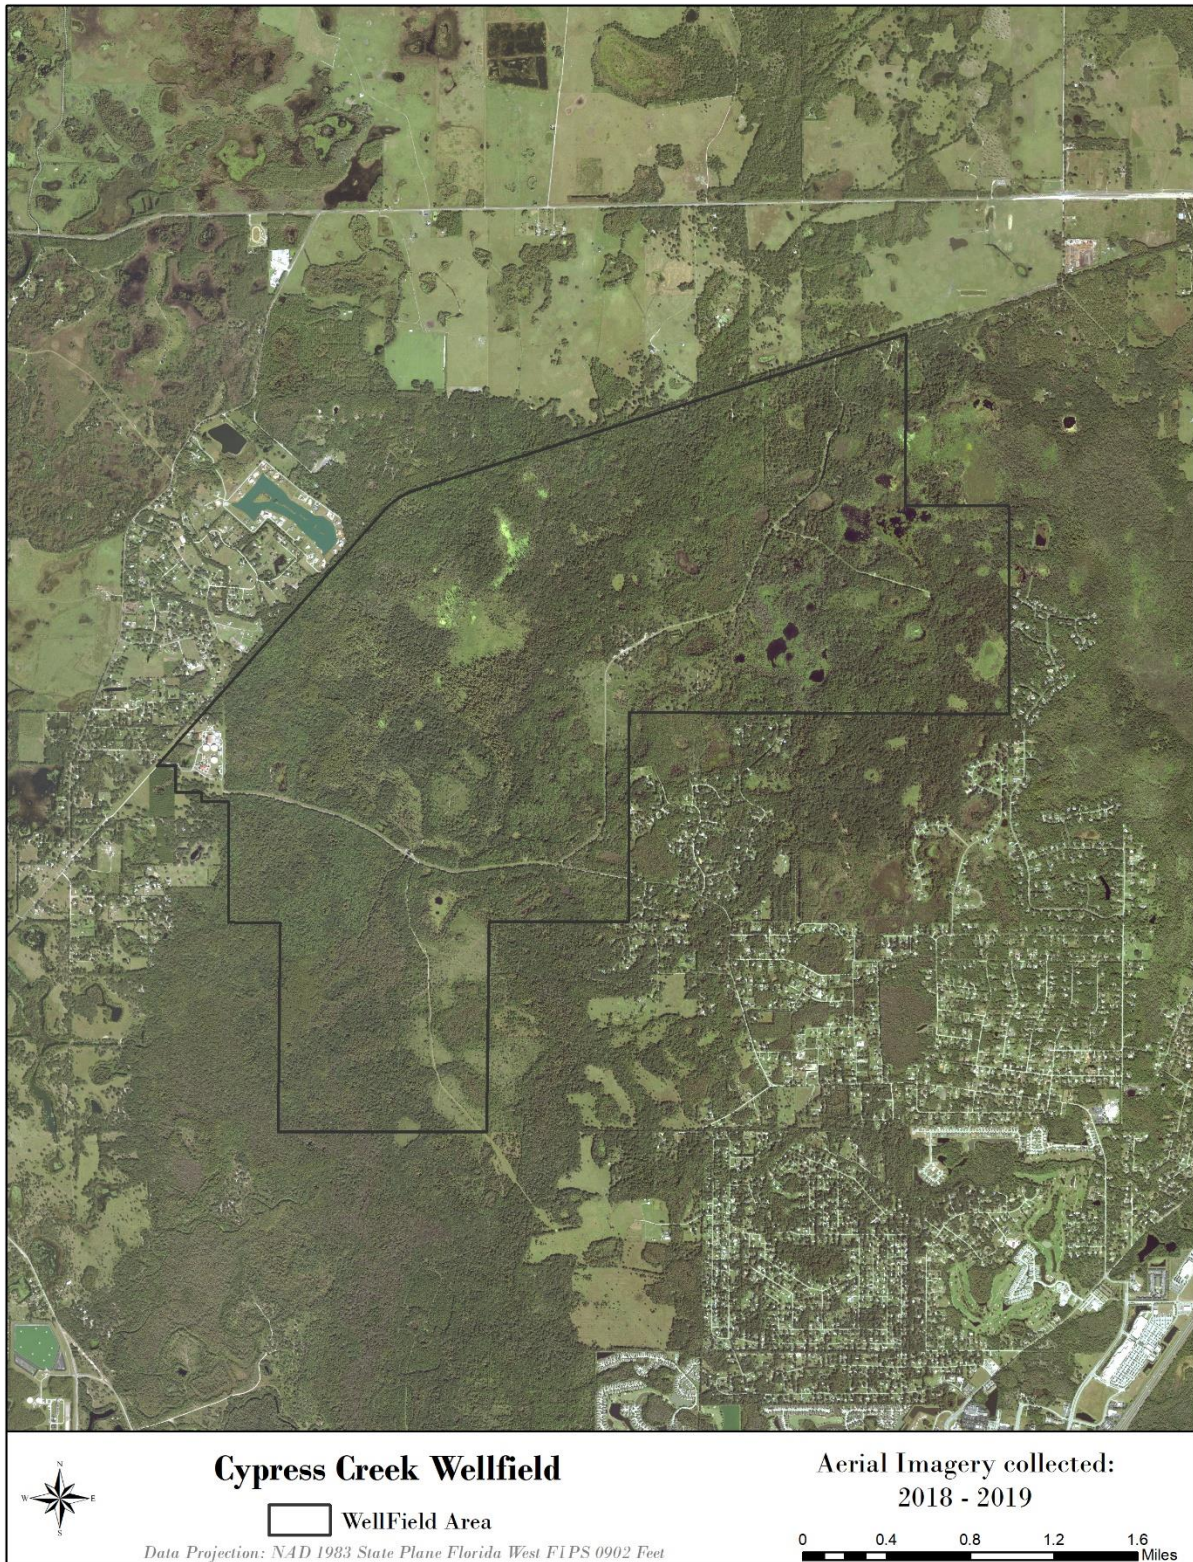
**Figure 3.21: Aerial Photograph of the Cypress Creek Wellfield Area from 2018 – 2019**

The subdivisions of Saddlewood Estates and Quail Hollow are both located adjacent to the east and southeast property boundary of the Cypress Creek Wellfield and are visible in the 2018 – 2019 aerial photograph in Figure 3.21. These communities experienced extensive flooding in the summer of 2003 as the region received over 80 inches of rainfall, with extensive rainfall recorded in December 2002 and June/July 2003. Water Year 2003 was also the first year of reduced pumping from the Cypress Creek and other regional wellfields as described in Section 3.15 of this report. The flooding within these two communities led to the creation of a surface water management system on the eastern side of the wellfield to alleviate some of the flooding that is now experienced in these communities on a frequent basis and to restore impacted wetlands on the east and central part of the wellfield. This project is described in detail in Section 3.13.2.3.

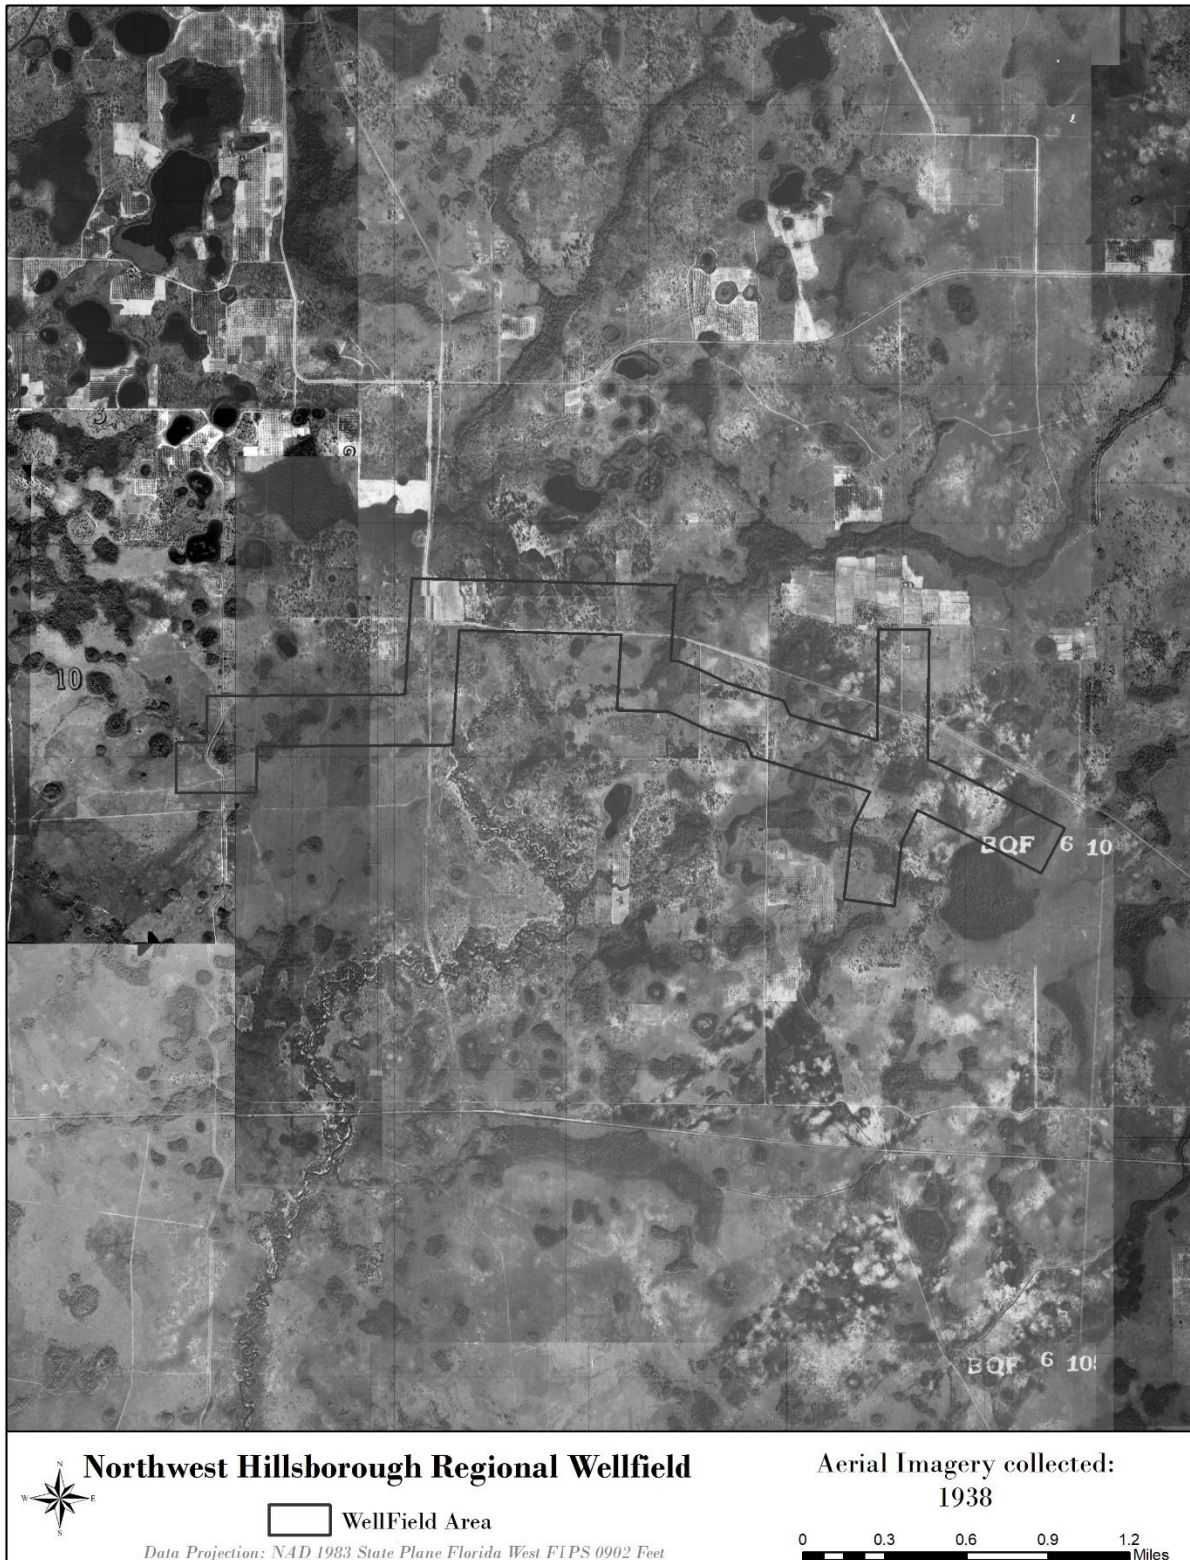
**Figure 3.22: Aerial Photograph of the Northwest Hillsborough Regional Wellfield Area from 1938**

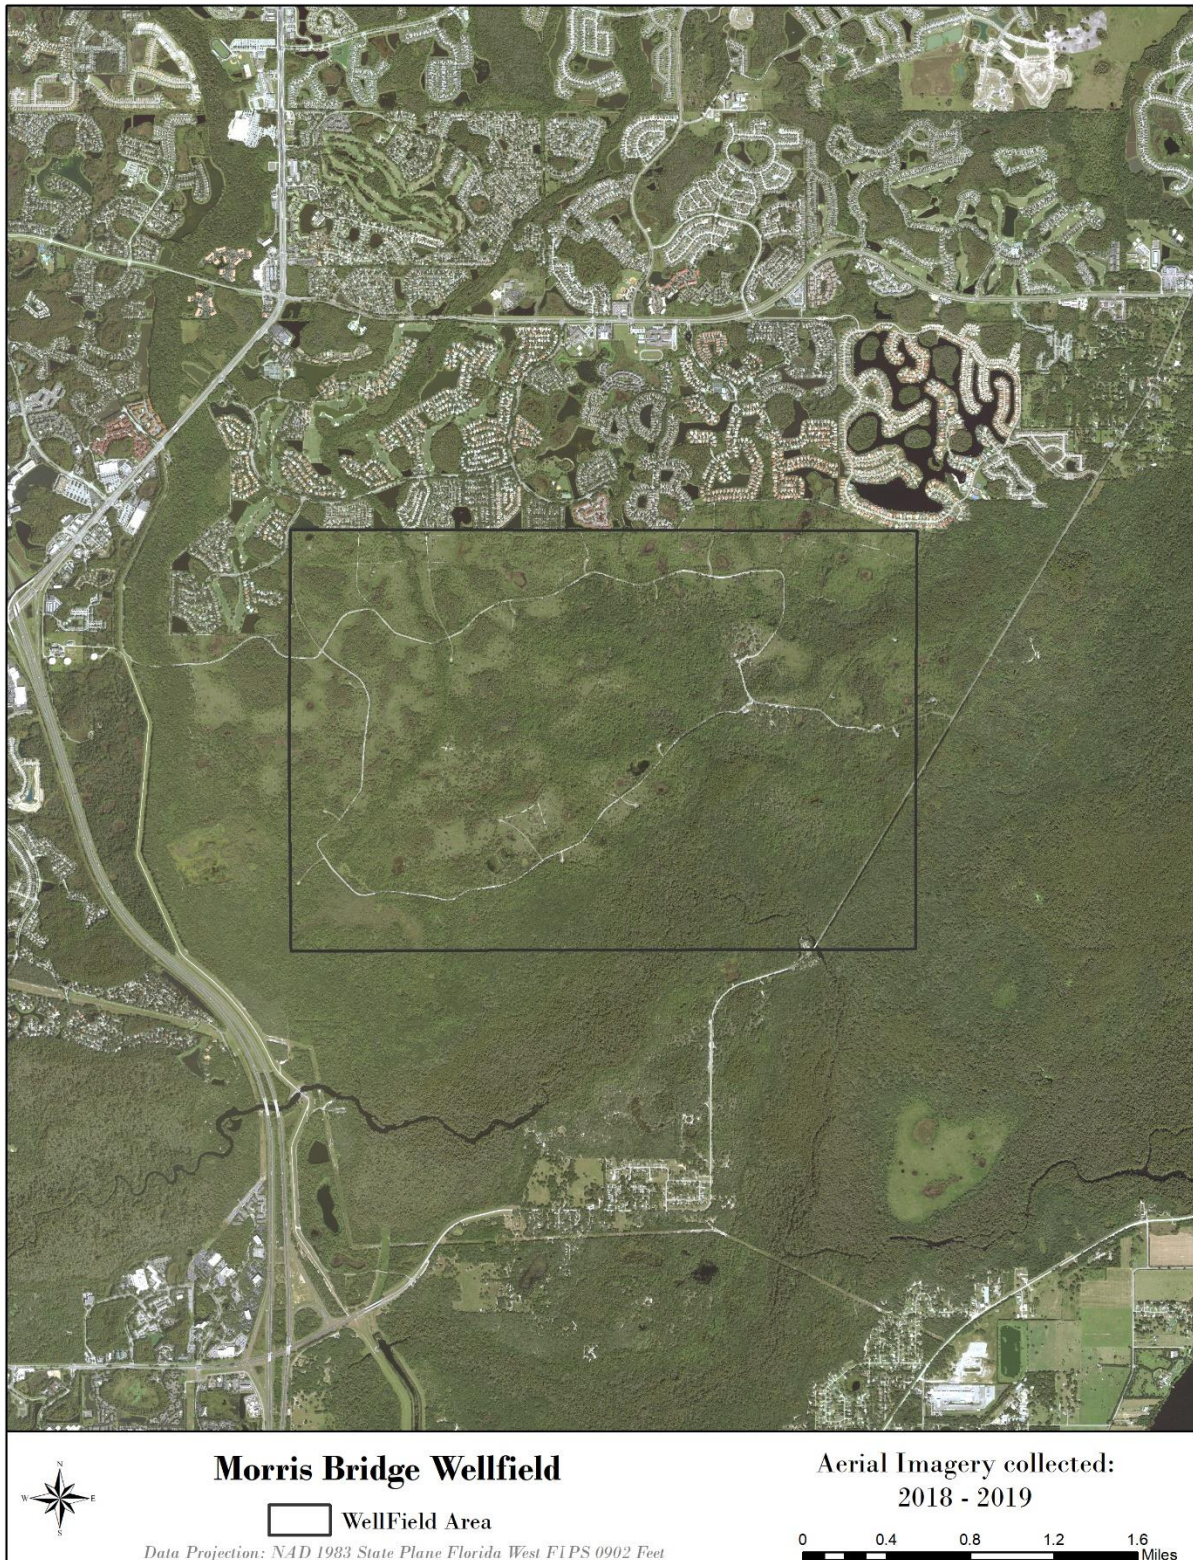
**Figure 3.27: Aerial Photograph of the Morris Bridge Wellfield Area from 2018 – 2019**

The wellfield property has remained in the same physical condition as when first developed by the City of Tampa; it is now maintained by the District as a day-use facility known as the Flatwoods Wilderness Park. In the early 2000's, Tampa Bay Water modified three of the drainage structures under the south loop road in 2005 to alleviate some of the vegetation impacts noted by the District and City of Tampa on both the upstream and downstream sides of the structures (Reynolds, Smith & Hills, 2003). The structure modifications also eliminated scouring of sediments near the structures by reducing the flow velocity of these channelized systems. Tampa Bay Water also restored an access trail near monitored wetland MBR-30 in 2019 to provide access to the site and potentially improve the hydroperiod and high-water levels in this wetland. Other physical feature changes are associated with the significant development that has occurred on the immediate northern and western boundaries of the wellfield. The Hunter's Green, Arbor Greene, and Cory Lake Isles developments were constructed in the 1990's and 2000's, have permitted stormwater management systems and are located within the headwaters of the Clay Gully and Wild Hog Slough systems. The extensive urbanization to the north and west of the wellfield are clearly visible in the aerial photograph from 2018 – 2019 (Figure 3.27).

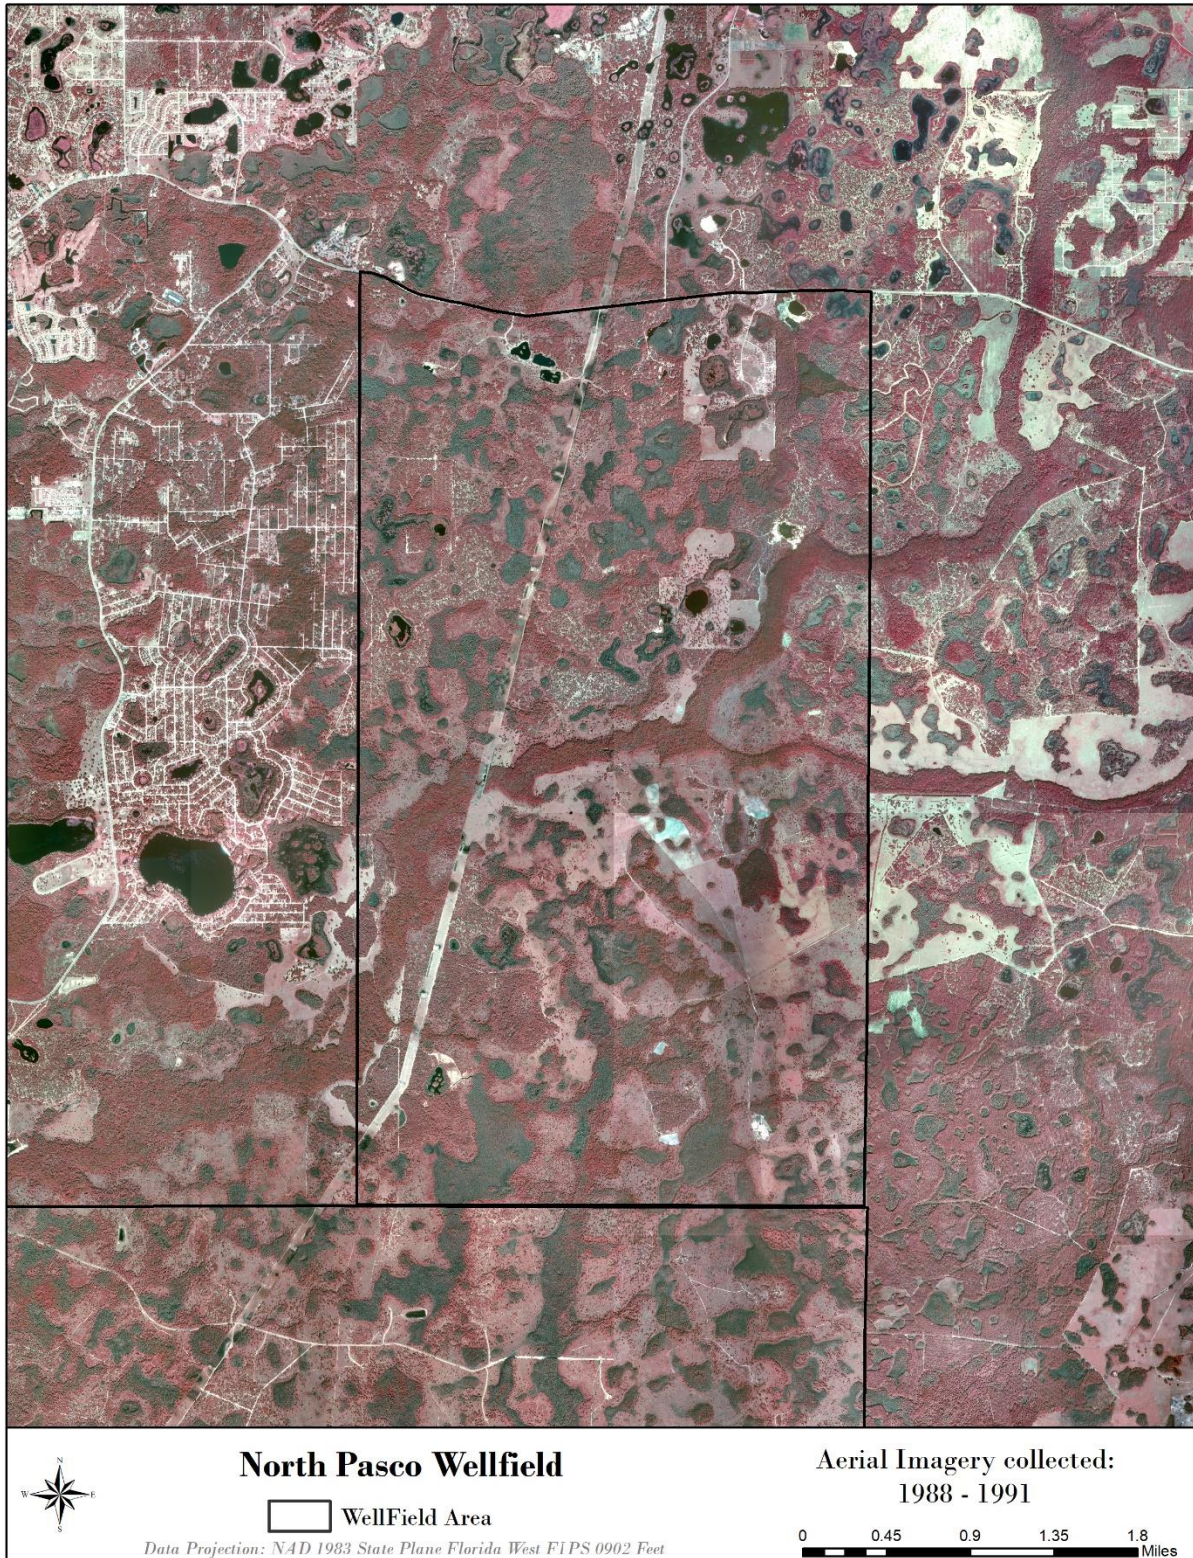
**Figure 3.32: Aerial Photograph of the North Pasco Wellfield Area from 1988 – 1991**

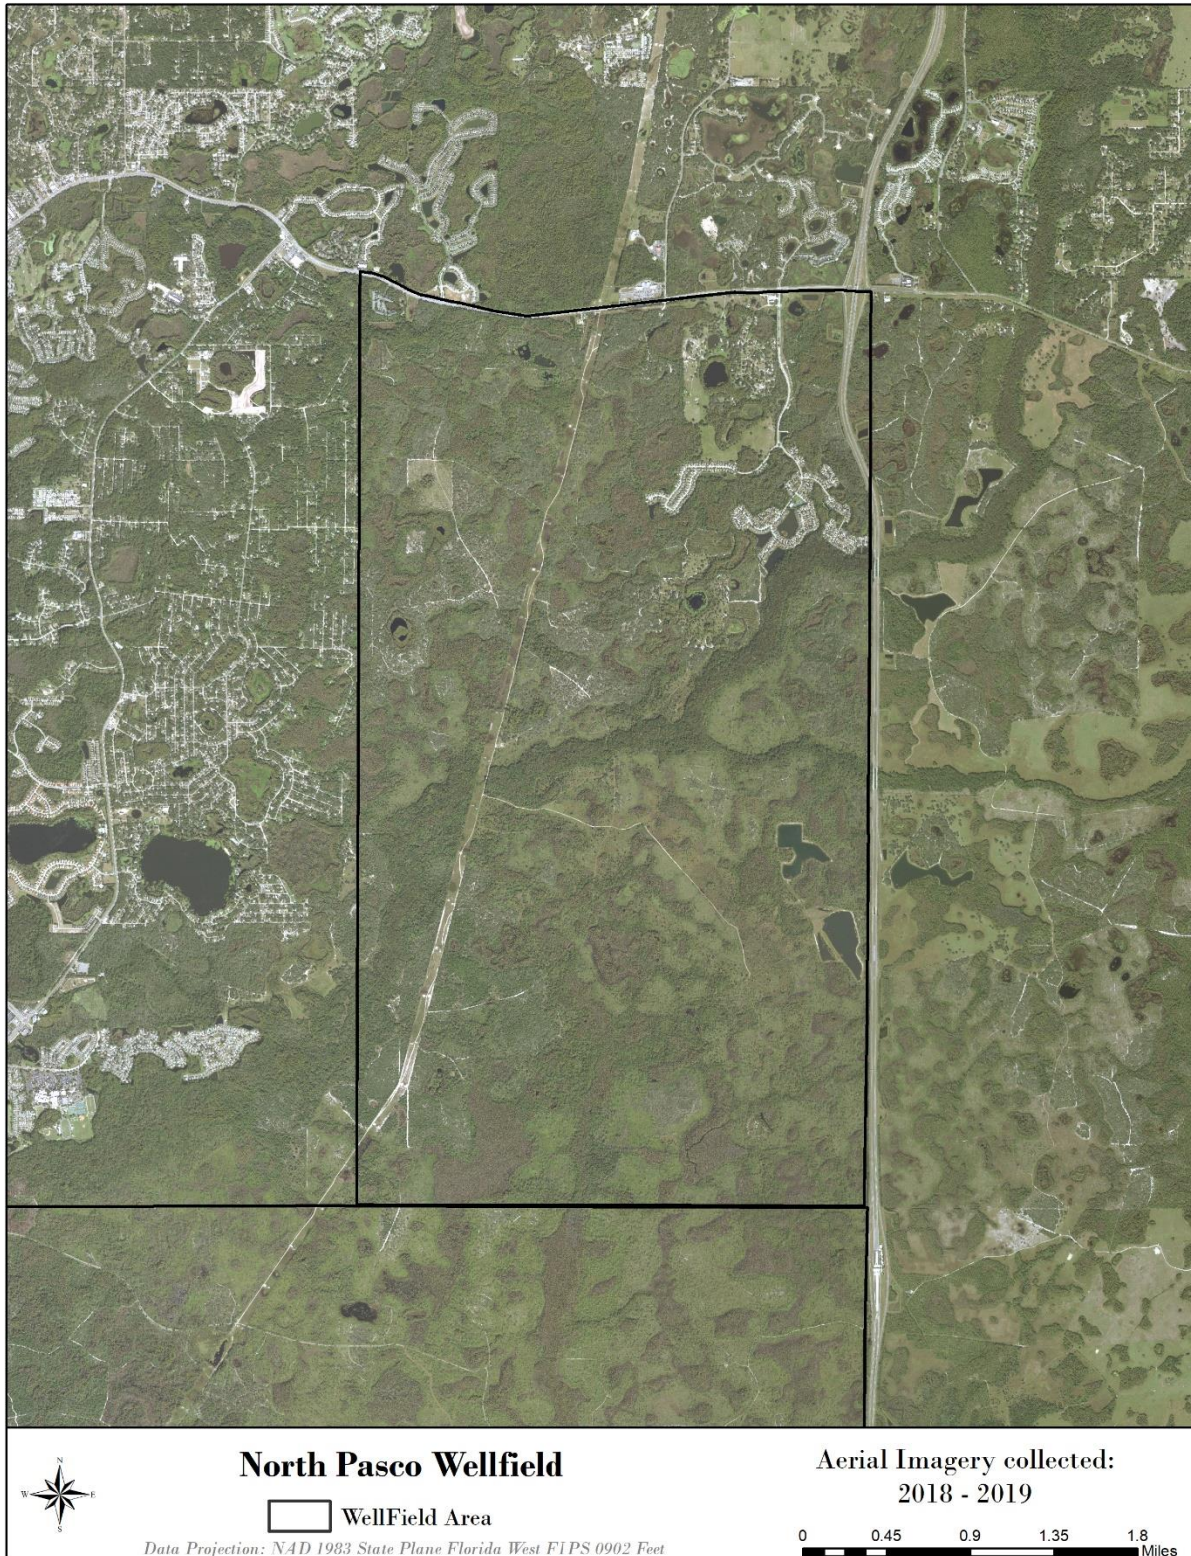
**Figure 3.33: Aerial Photograph of the North Pasco Wellfield Area from 2018 – 2019.**

The property known as the Serenova Tract was acquired by the Florida Department of Transportation and preserved in its natural state to mitigate for impacts resulting from the construction of the Suncoast Parkway located along the east side of the property (Figure 3.33). This property is approximately 6,500 acres in size and ownership and the overlying conservation easement was transferred to the District and is now included as part of the Starkey Wilderness Preserve (Southwest Florida Water Management District, 2005b). Some new residential development can be seen on the north side of the wellfield property near State Road 52 in the recent aerial photograph, but the majority of the area remains undeveloped at this time.

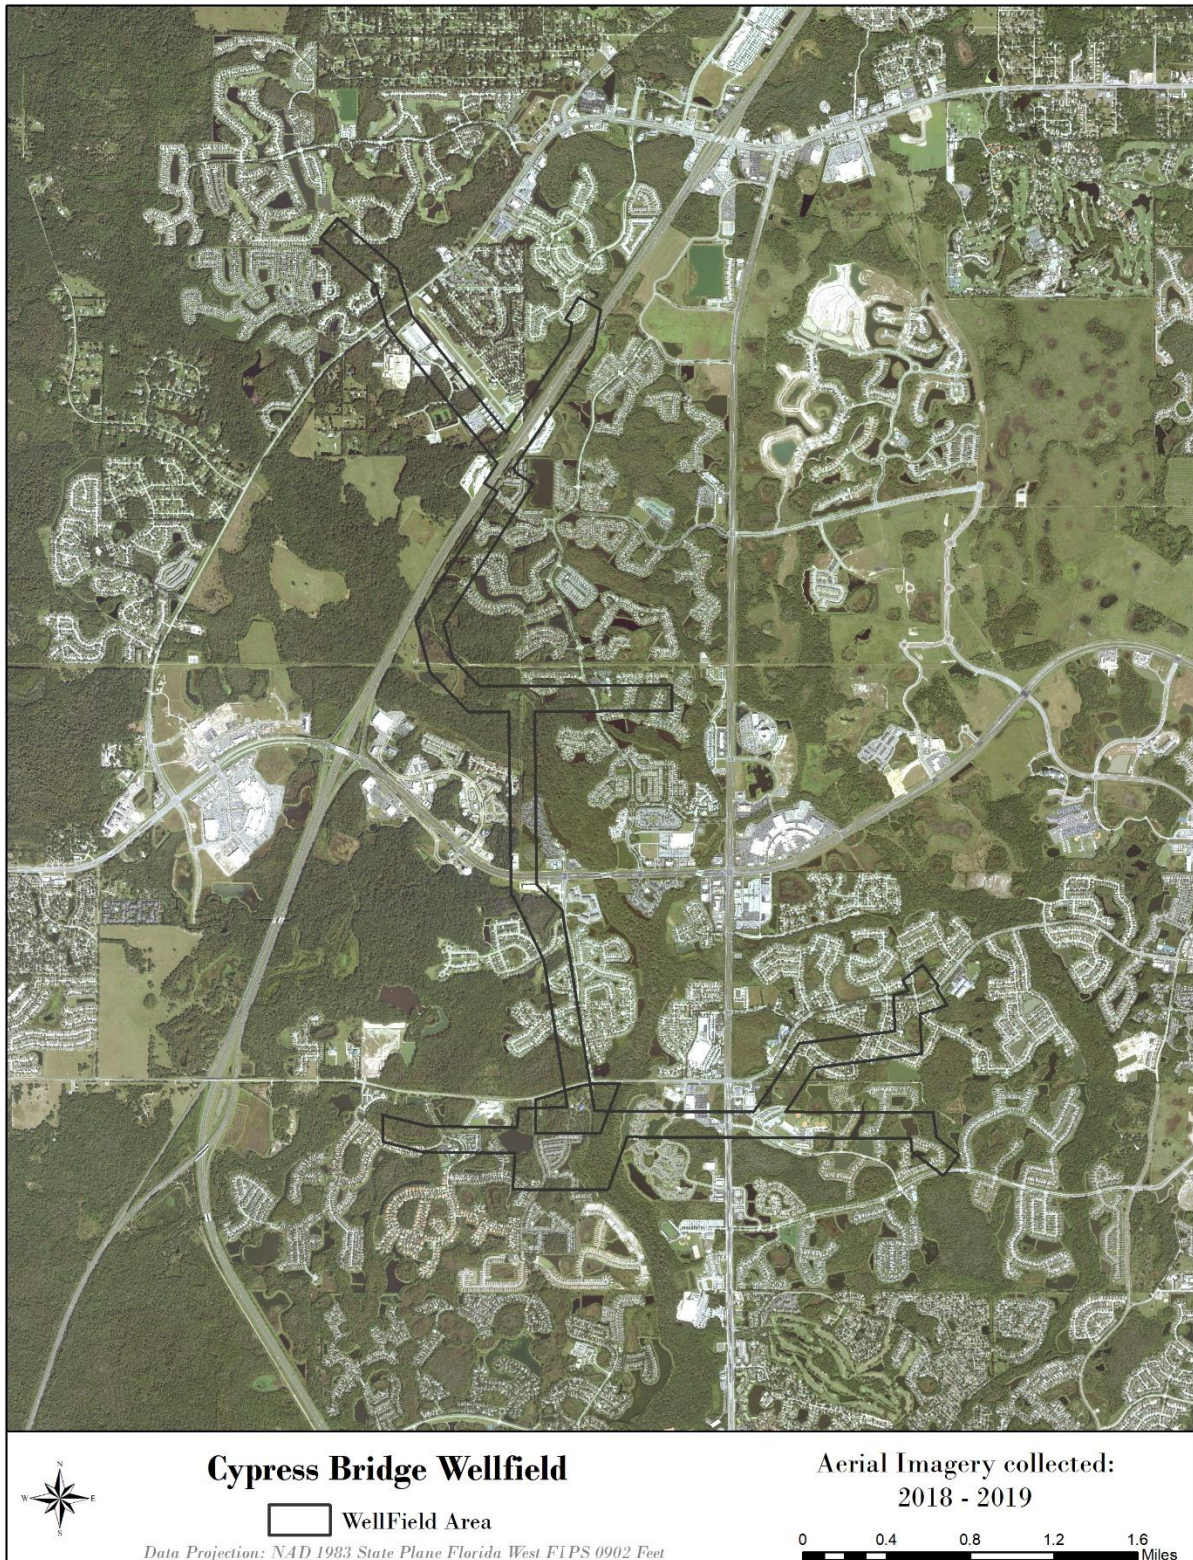
**Figure 3.35: Aerial Photograph of the Cypress Bridge Wellfield Area from 2018 – 2019**

A total of ten production wells were eventually constructed in northern Hillsborough County and south-central Pasco County along County Road 581 with the northern production wells located to the west of I-75 (Figure 3.2). Production well CYB-3 was never constructed but the other ten production wells could produce the permitted quantities. The final six production wells for the wellfield were constructed in 1992 (Schreuder & Davis, Inc., 1993). At that time, the wellfield area was largely in a rural setting with land in a natural state or cattle ranch operations. However, the area quickly changed to an urban setting with multiple planned communities with permitted stormwater management systems. At the time of this report, most of the formerly open land has been developed with the exception of some land in Pasco County to the east of County Road 581, between the County line and State Road 54. More developments have been permitted in this area and various phases are currently under construction (Figure 3.35).

At the time when the final wellfield production wells were constructed in 1992, the wellfield area was largely in a rural setting with much of the land used for cattle ranch operations or in a natural state. The land use quickly changed to an urban setting with multiple planned communities and permitted stormwater management systems. At the time of this report, most of the formerly open land has been developed with the exception of some of the land in Pasco County to the east of County Road 581, between the County line and State Road 54; however, developments have been permitted in this area and phases of those developments are currently under construction (Figure 3.35).

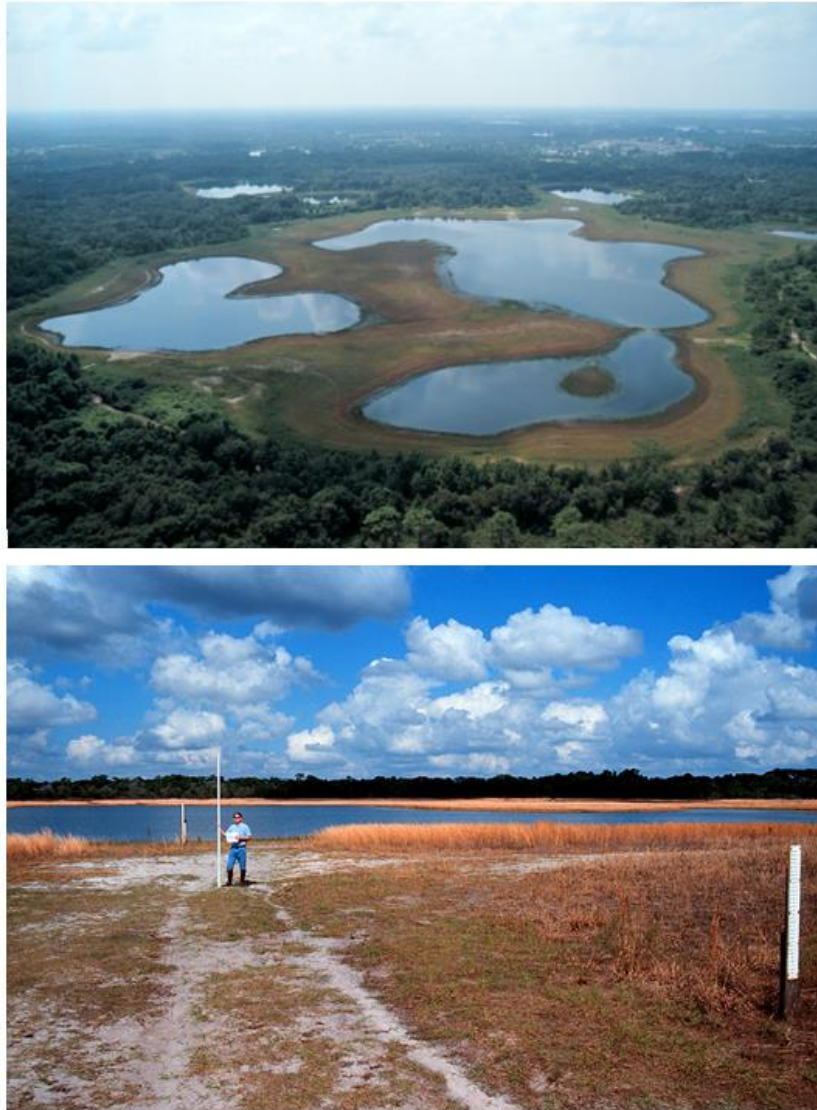
The hydrographs are effective at showing the water level data and the range of water level fluctuation at monitored sites; however, they cannot convey the environmental condition of these lakes and wetlands. Two photographs of Lake Rogers from 2002 are shown in Figure 3.50. The top photograph is an oblique aerial view of the lake showing that the water level in the lake had dropped to the point where much of the lake bottom sediments were exposed and the lake had separated into four pools. This lake is located in the original section of the Cosme-Odessa Wellfield and the region was at the end of an extreme drought when these photographs were taken. The bottom photograph is a ground-level view of Lake Rogers at the same general time and shows two of the five staff gages in the lake; the lake had receded to the fifth and deepest staff gage at the time of the photograph. Figure 3.51 shows a ground-level view of Starvation Lake in 2001 when the water level was as low as it was in the early 1970's (Figure 3.49). Stanford Lake is located just west of the Cypress Creek Wellfield and this lake was completely dry in May of 2002 before the severe regional drought finally ended (Figure 3.52). These photographs convey the visual impact of extremely low water levels in area lakes during a time when wellfield pumping was at its highest and rainfall was at its lowest. These water level conditions certainly occurred at some locations in the past; however, photographs from earlier years are generally unavailable or of poor quality. Nonetheless, the conditions shown in these recent lake photographs are what the water managers, government officials and the public were discussing in the 1990's.

**Figure 3.50: Aerial View and Ground-level View of Lake Rogers in 2002** (photos courtesy of District staff)

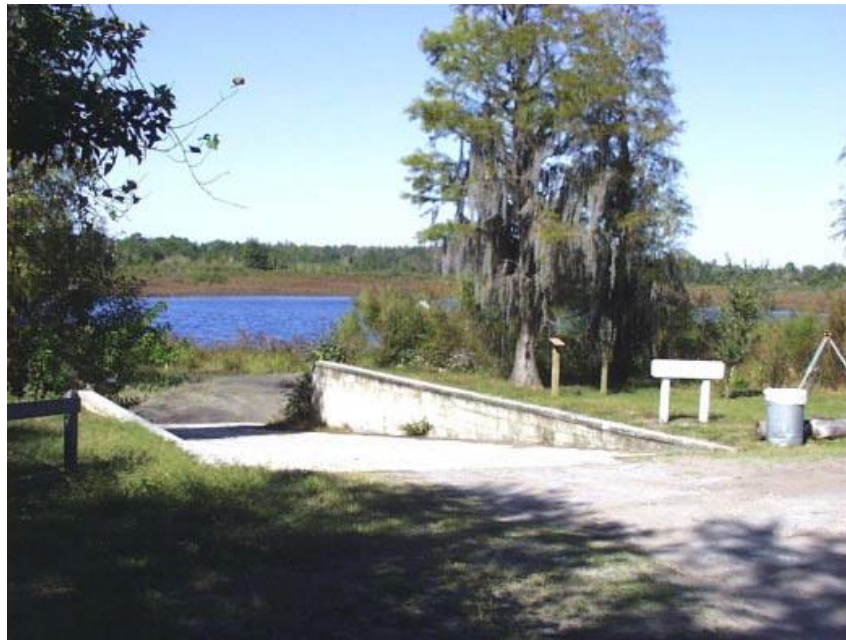
**Figure 3.51: Starvation Lake 2001**

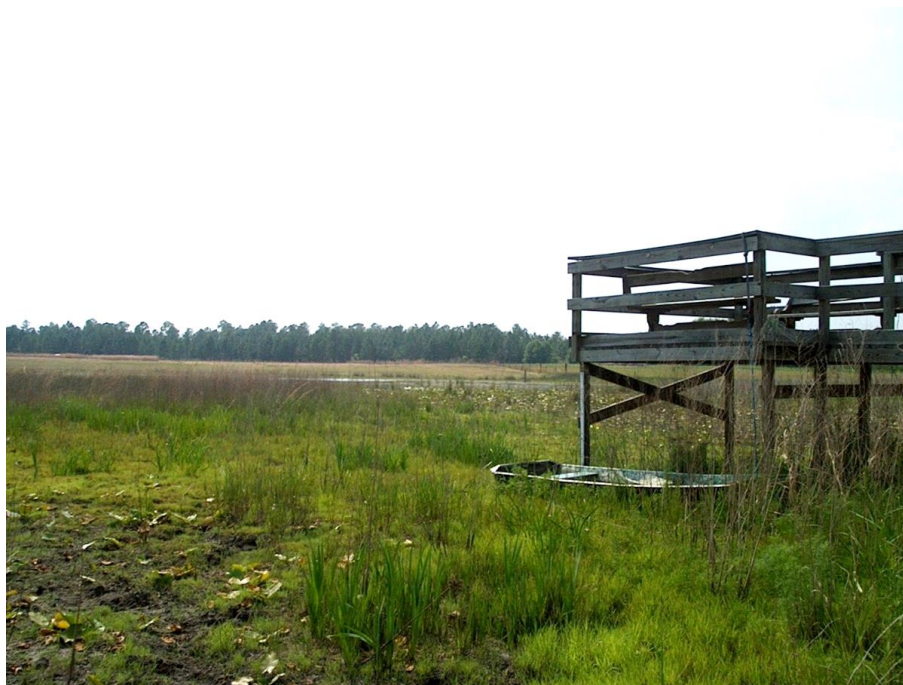
**Figure 3.52: Stanford Lake (CYC C-03) – May 2002 (photo courtesy of RS&H staff)**

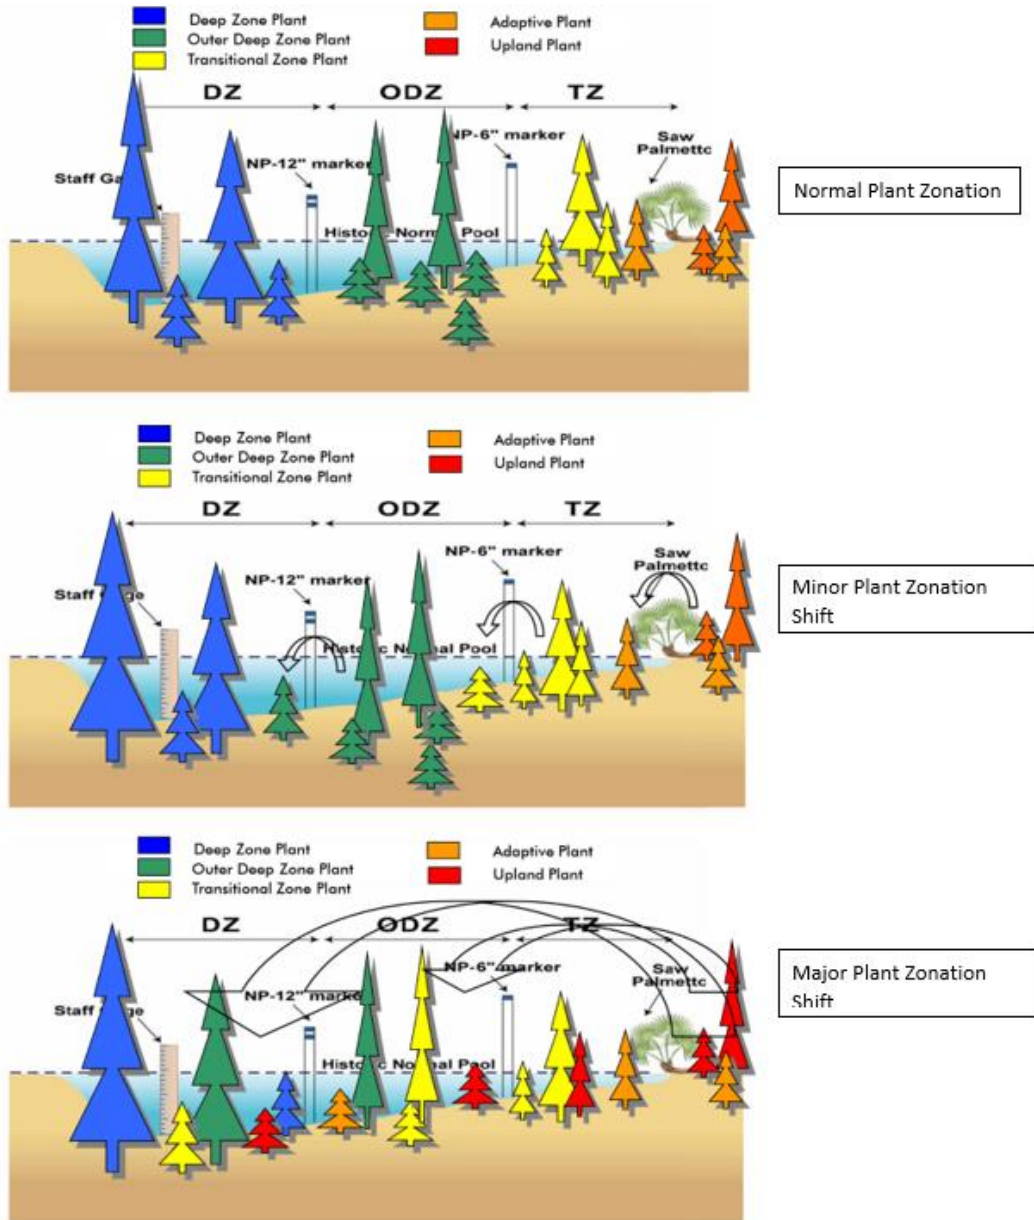
**Figure 3.54: Illustration of the Progression of Upland Plant Migration into Wetlands**

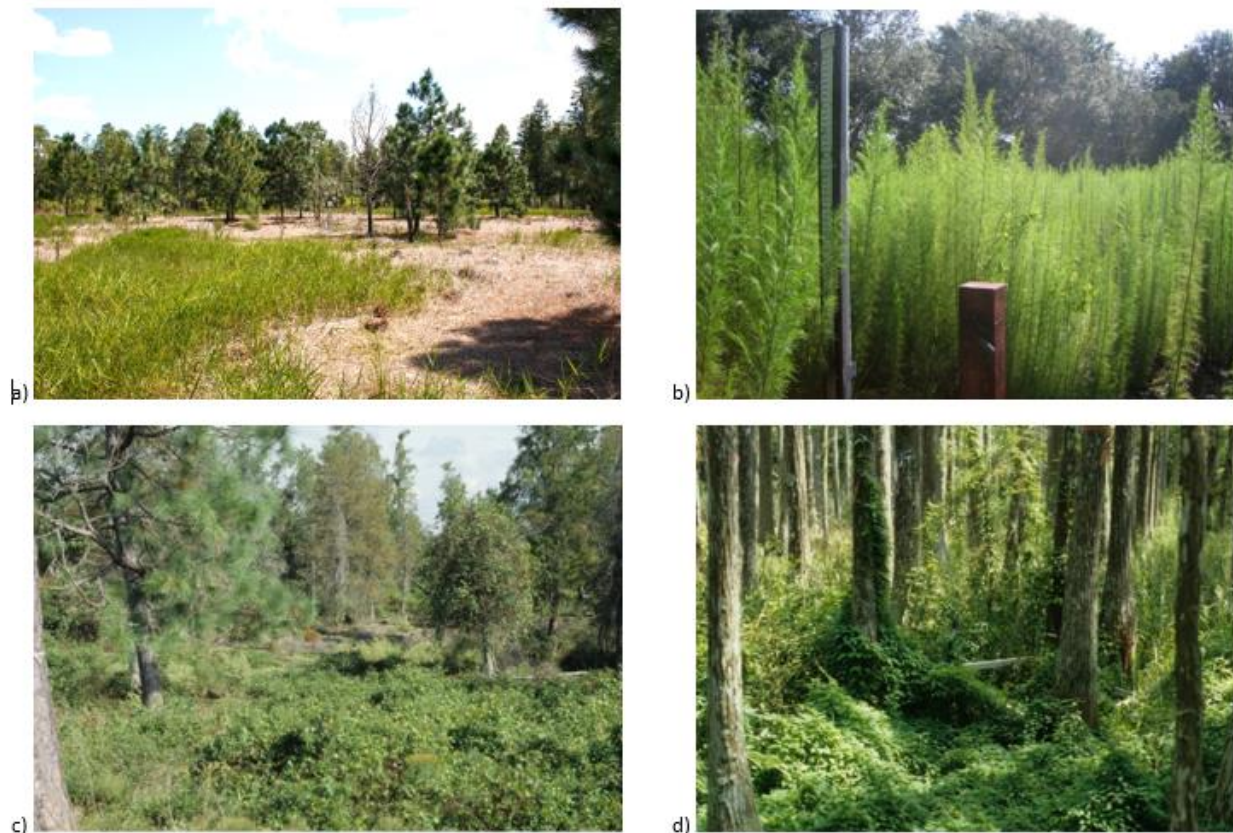
Adverse changes in wetland vegetation in four wetlands can be seen in the photographs presented in Figure 3.55. Wetland W-16 was one of the first wetlands to show significant water level change at the Cypress Creek Wellfield with no standing water for multiple years and the water table was often more than 10 feet below the bottom of the wetland. The soils of this marsh continued to support wetland vegetation; however, the presence of mature slash pine (*Pinus elliottii*) in the center of the wetland is a negative vegetation change. Slash pine is considered an adaptive species which will germinate in drier soils but can tolerate wetter soils once the trees mature. Dogfennel (*Eupatorium capillifolium*) is another adaptive plant and the presence of this species in the deepest part of Wetland S-005 at the Starkey Wellfield is another negative vegetation change. At the time of the photo, the Dogfennel was almost as

tall as the staff gage indicating it had been there for some time. This species will die out relatively quickly if the wetland is again inundated for sustained periods of time. Wetland EWWF-3 at the Eldridge-Wilde Wellfield also had mature pines within the wetland along with other upland and transitional vegetation at the time of the 1989 photograph. The photo of Wetland C at the Cypress Creek Wellfield shows that nuisance or exotic species like Skunkvine (*Paederia foetida*), another adaptive species, can become established during periods of sustained low water levels

**Figure 3.55: Photographs of Changes in Wetland Vegetation; a) Cypress Creek Wetland W-16 (2016), b) Starkey Wetland S-005 (2002), c) Eldridge-Wilde Wetland EWWF-3 (1989), and d) Cypress Creek Wetland C (1994). (Photo b provided courtesy of GPI, Inc. staff and photos c and d provided courtesy of District staff)**

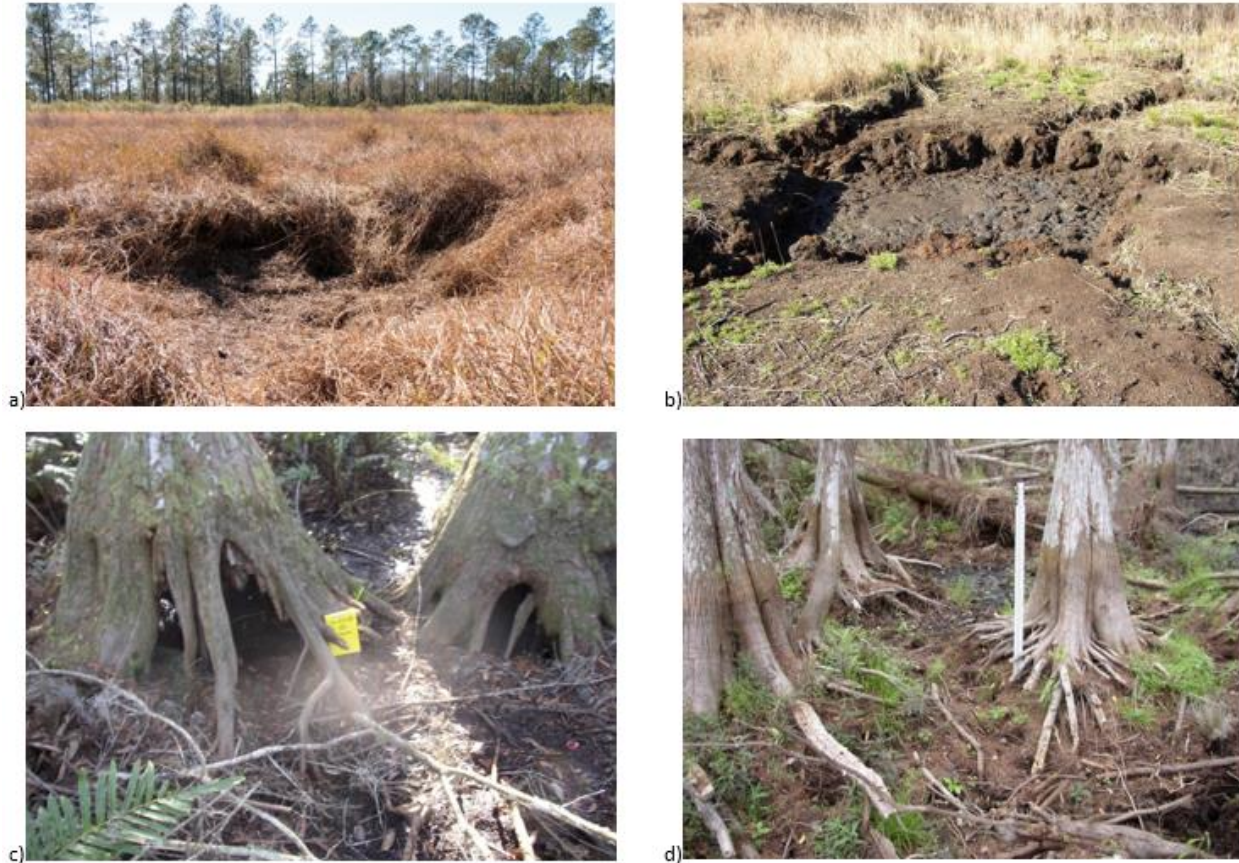
**Figure 3.56: Photographs of Wetland Soil Subsidence; a) Morris Bridge Wetland MBR-10 (2017), b) Starkey Wetland S-24 (2007), c) Section 21 Wetland NW-53 (2007), and d) Starkey Wetland #3 (2007). (Photos b – d provided courtesy of District staff)**

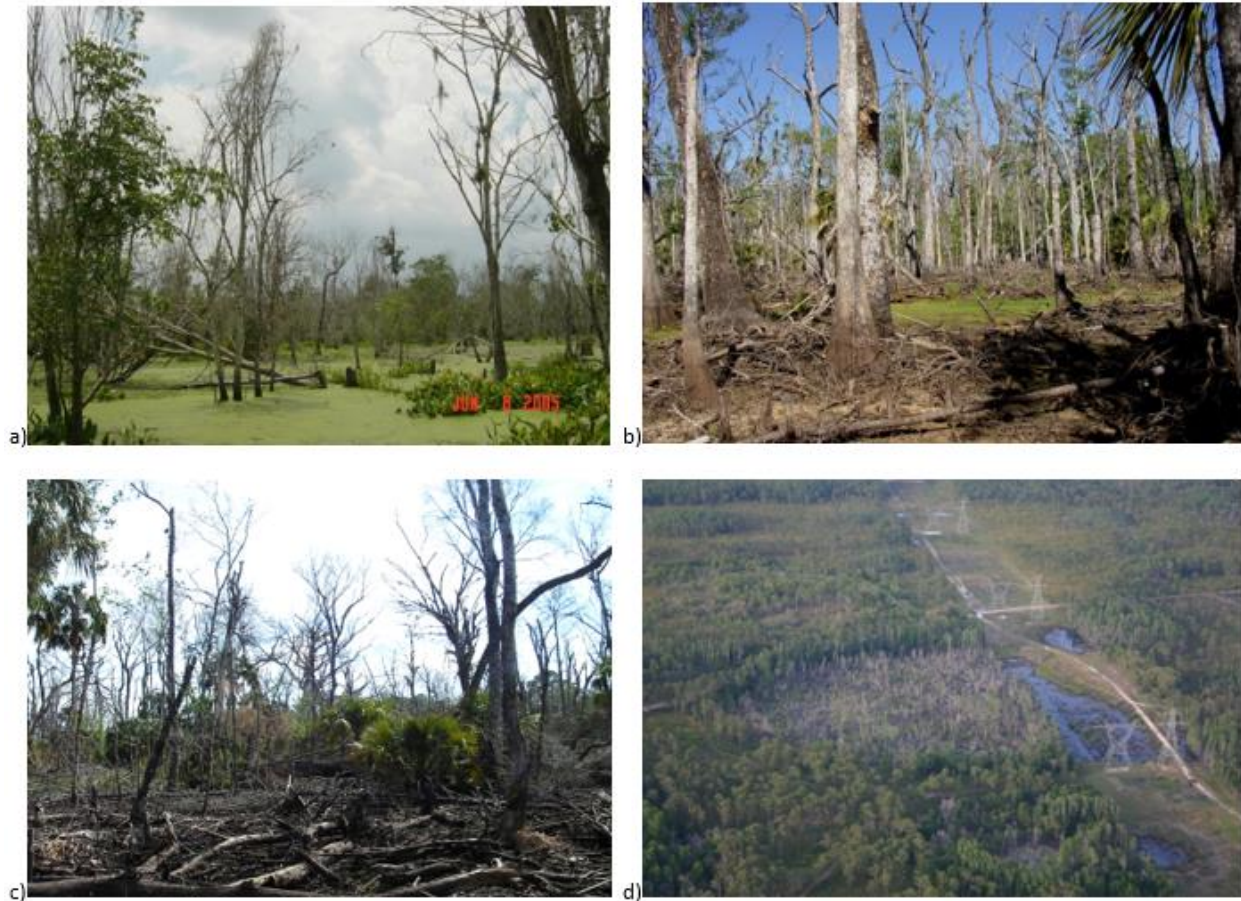
Photographs a – c in Figure 3.57 show the treefall in the Cypress Creek Floodplain described above at three of the long-term monitoring stations within the floodplain (Wetlands W-21, W-44 and W-49). These photographs show the treefall in the floodplain at its greatest extent with most of the trees either standing dead or having already fallen. High rainfall during 2003 and 2004 brought high flows through the Cypress Creek Floodplain and it is likely that many trees in the floodplain fell during this high-flow period after having experienced soil subsidence in the prior years; the oxidized soils were not able to support the floodplain trees in the presence of high surface water flows. Some of the fallen or standing dead trees were also species that had become established in the floodplain during times of reduced inundation. The oblique aerial photograph of Wetland S-036A at the Starkey Wellfield from 2005 also shows severe treefall. This wetland in the center of the Starkey Wellfield had experienced soil subsidence for several years and it is thought that the treefall in this wetland happened during a high-wind event because most trees fell in one direction. If that was the case, the weakened soil structure under the trees was not enough to support the trees during the high wind event.

**Figure 3.57: Photographs of Treefall; a) Cypress Creek Wetland W-49 (2005), b) Cypress Creek Wetland W-44 (2006), c) Cypress Creek Wetland W-21 (2006), and d) Starkey Wetland S-036A (2005).** (Photos a and c provided courtesy of C. Grizzle, photo b) provided courtesy of District staff, and photo d provided courtesy of GPI, Inc. staff)

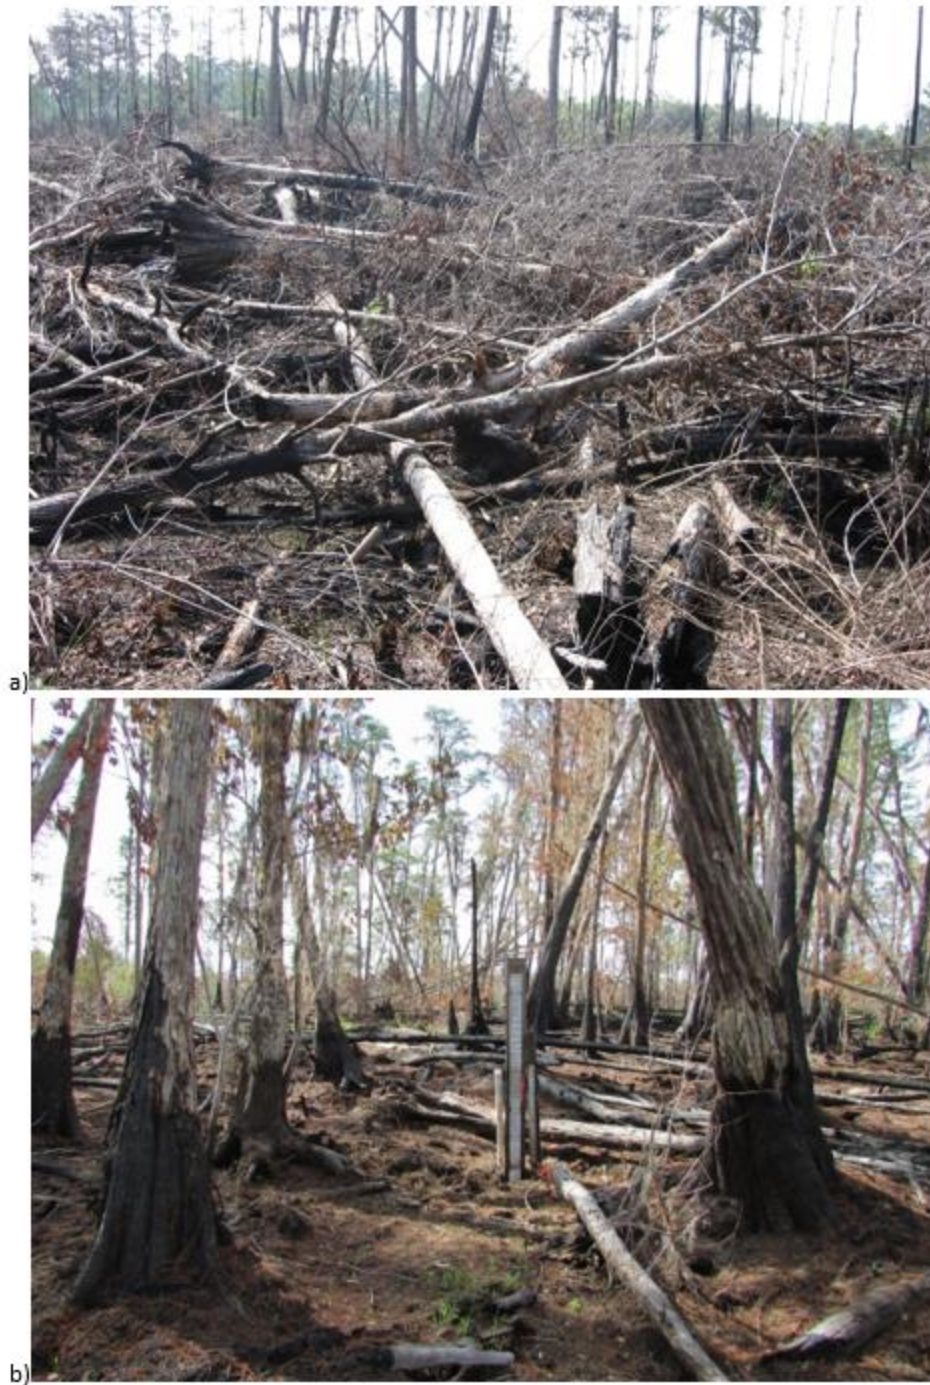
**Figure 3.58: The Effects of Wildfire on Wetlands; a) Starkey Wetland S-005 (September 2007), and b) Starkey Wetland S-052 (June 2017). (Photos provided courtesy of GPI, Inc. staff)**
