# Tampa Bay Water Recovery Assessment: Final Report of Findings

Final Report  
Consolidated Water Use Permit  
September 29, 2020

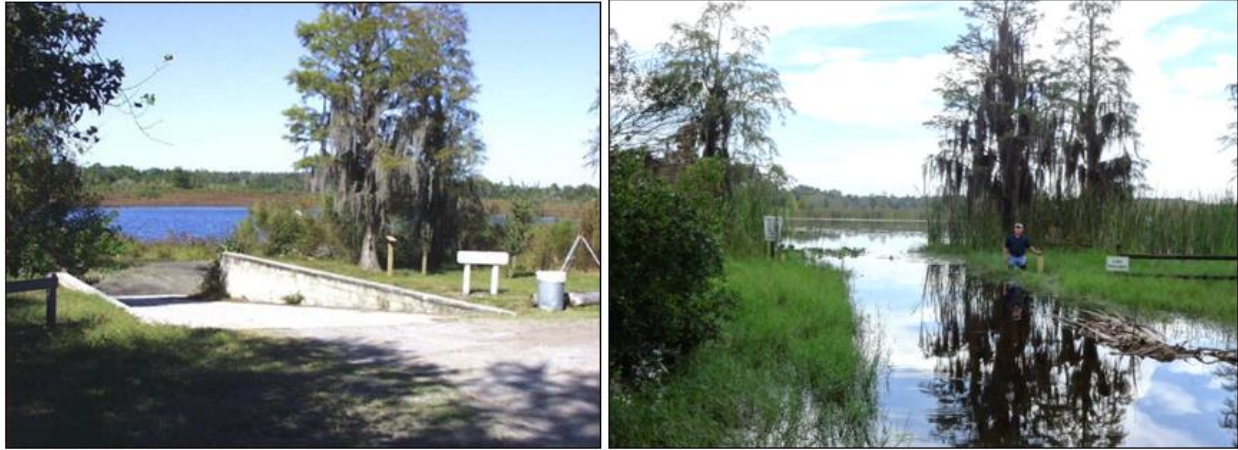
The hydrographs presented in this section and the data in the annual wellfield monitoring reports document the environmental improvement seen on and near the northern wellfields; however, it takes photographs to clearly illustrate how significantly conditions have improved. Photographs from seven lakes and wetlands are presented with one photograph for each site before the reduction in wellfield pumping and one taken a few years after the pumping reduction at that wellfield. The improvement in water level in Starvation Lake at the Section 21 Wellfield is shown in Figure 3.72. The two photographs were taken in 2001 and 2015 and the lake water level increased approximately 14 vertical feet between the two photos. The 2001 photograph was taken during a time of extreme regional drought with a relatively high wellfield rate of groundwater pumping. The standing water conditions shown in the 2015 photograph are typical for most years following the reduction in pumping at this wellfield in 2004. Figure 3.73 shows photographs from 2002 and 2011 at Stanford Lake located just west of the Cypress Creek Wellfield. This is a shallow lake that is typically eight feet deep following the summer rains but the lake

has reached depths of approximately 11 to 12 feet following the pumping reduction at this wellfield. At these very high water levels, the lake overflows into adjacent low-lying pasture areas surrounding the lake.

**Figure 3.72: Starvation Lake at the Section 21 Wellfield, Water Level Improvement; photos from 2001 and 2015**

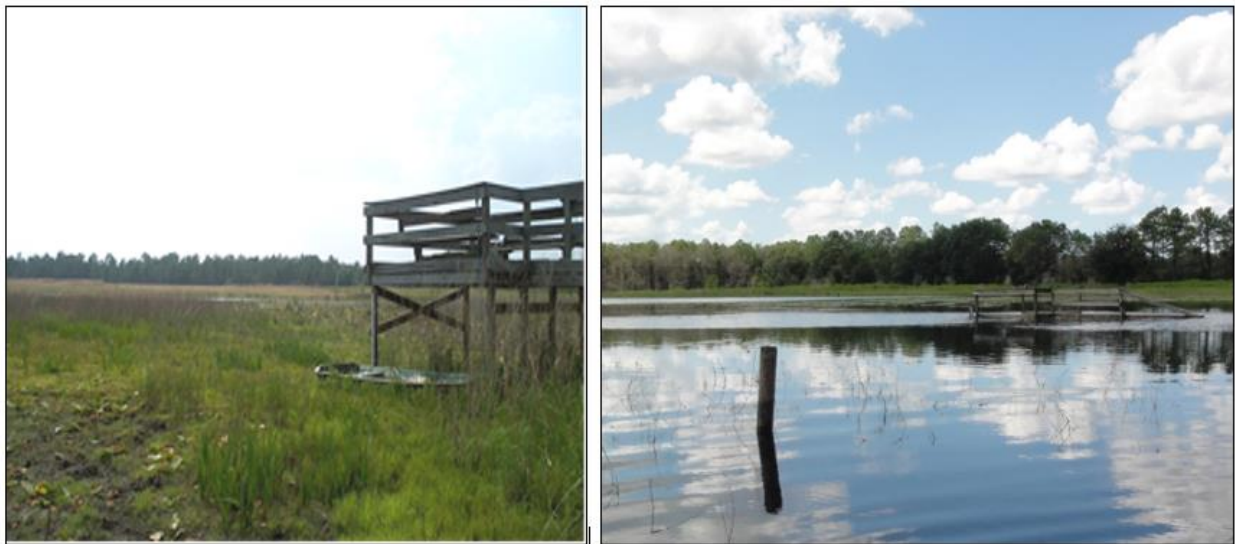
**Figure 3.73: Cypress Creek Wellfield Monitoring Site C-03 (Stanford Lake), Water Level Improvement; photos from May 2002 and February 2011 (Photos provided courtesy of C. Grizzle)**

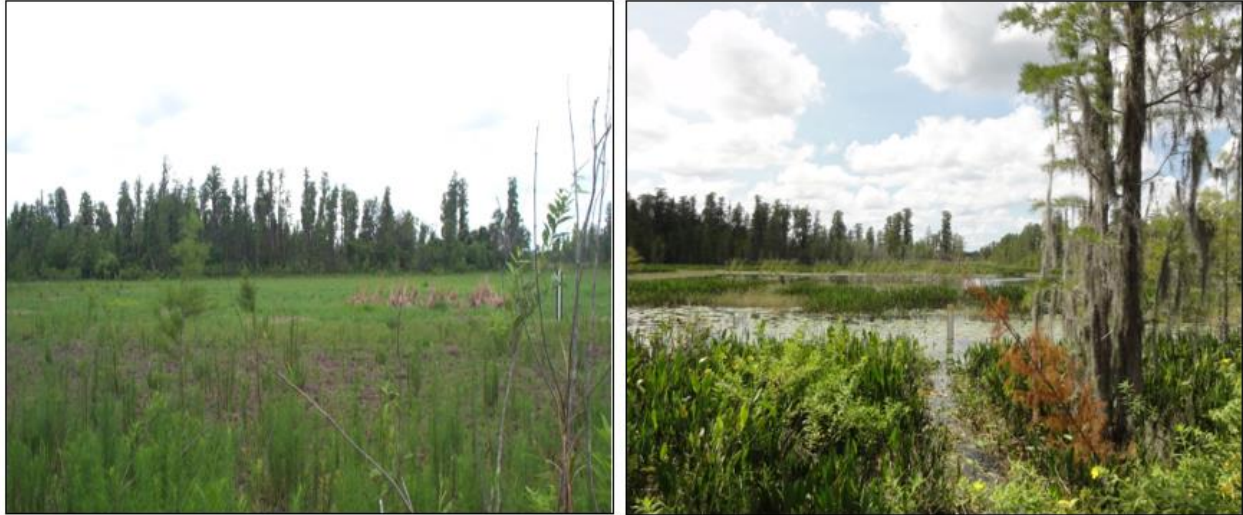
The return of water levels and vegetation can be seen in the before-and-after photographs for wellfield wetlands. Figure 3.74 shows the improvement of wetland C-25 located between the Cross Bar Ranch and Cypress Creek Wellfields between 2001 and 2016. The improvement in wetland vegetation is apparent in the two photographs presented in Figure 3.75 for wetland W-39 at the Cypress Creek Wellfield. The early photograph was taken in 2009 after the reduction in wellfield pumping but at the end of a multi-year drought event and the visible groundcover is either dead wetland species or upland plants. By 2016, more typical water levels had returned to this wetland allowing wetland vegetation to replace the upland

**Figure 3.74: Cross Bar Ranch Wetland C-25; photos from March 2001 and 2016, Water Level and Vegetation Improvement (Photos provided courtesy of C. Grizzle)**

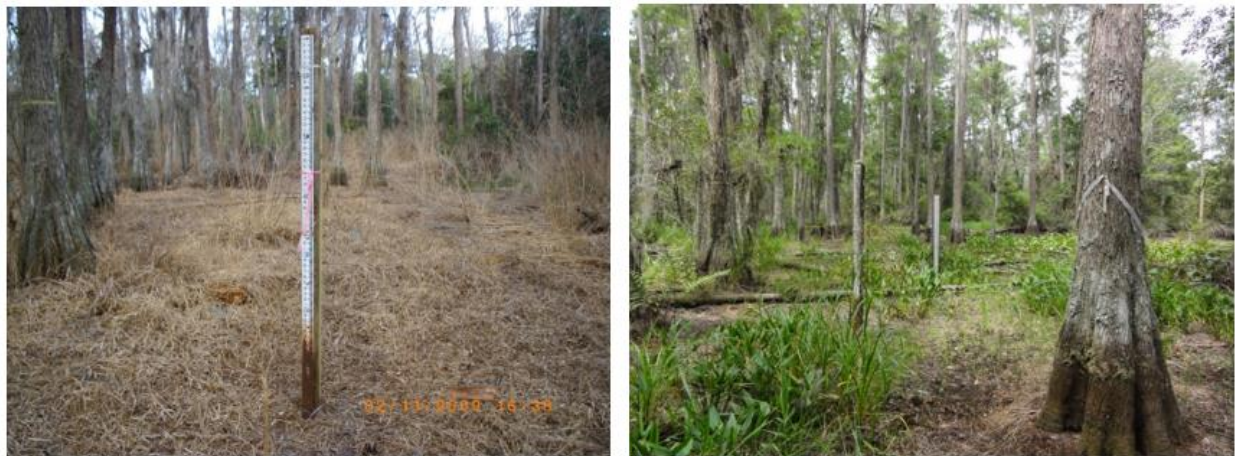
**Figure 3.75: Cypress Creek Wellfield Wetland W-39, Vegetation Improvement; photos from 2009 and 2016 (Photos provided courtesy of C. Grizzle)**

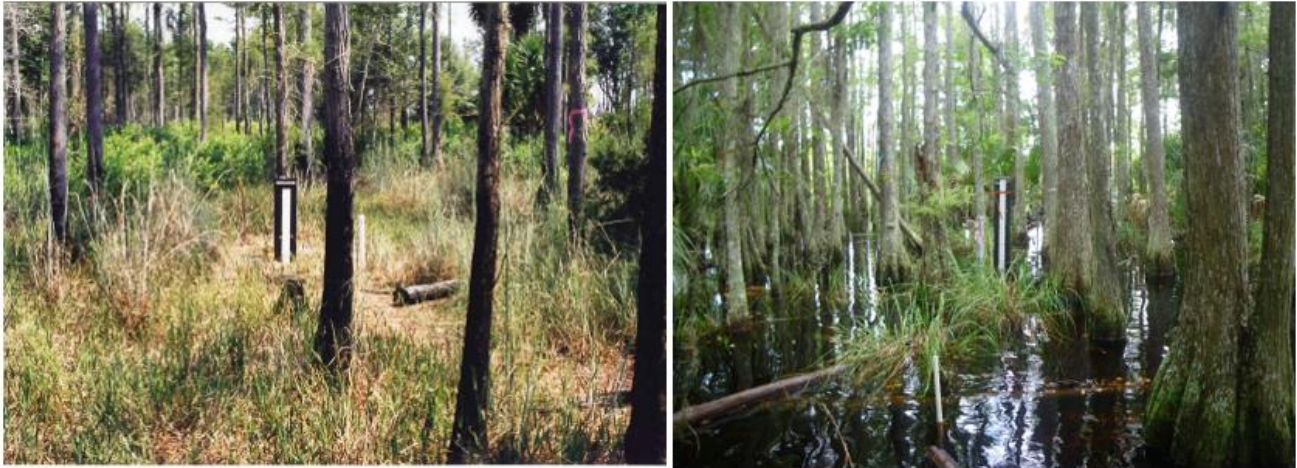
vegetation that had grown in the deeper wetland zones. Improvements to water levels and wetland vegetation can also be seen in the two photographs of wetland W-46 at the Cypress Creek Wellfield between 1999 and 2010 (Figure 3.76). Wetland S-024 at the Starkey Wellfield is a wet prairie system that was dry and filled with upland vegetation in 2000 but sustained water levels and wetland vegetation returned to the site following the pumping reduction at this wellfield in December 2007 (Figure 3.77).

**Figure 3.76: Cypress Creek Wellfield Wetland W-46, Water Level and Vegetation Improvement; photos from September 1999 and September 2010 (Photos courtesy of RS&H, Inc. staff)**

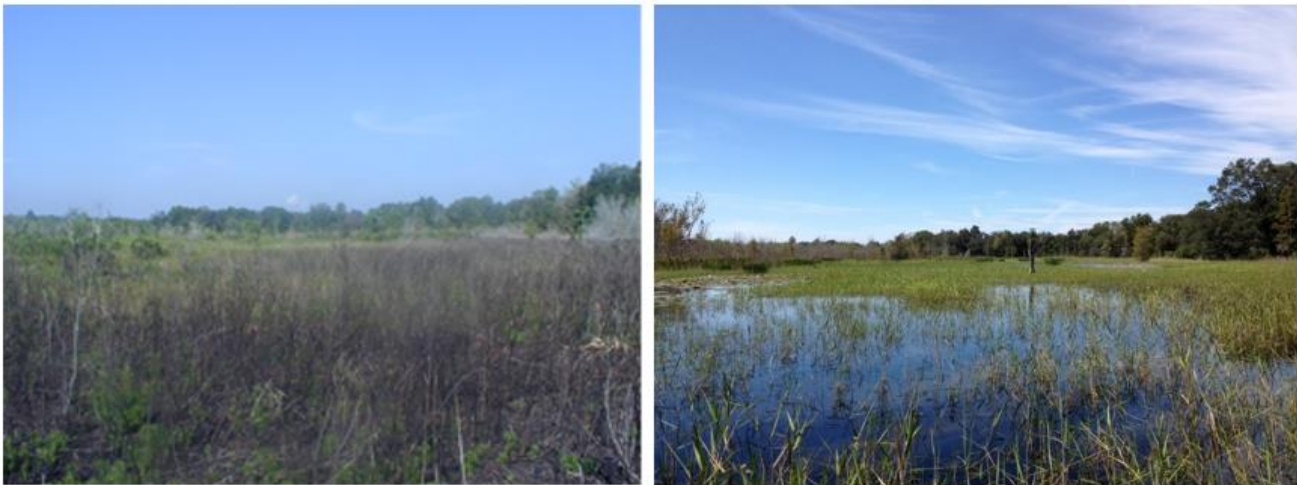
**Figure 3.77: Starkey Wellfield Wetland S-024, Water Level and Vegetation Improvement; photos from 2000 and 2013 (Photos courtesy of GPI, Inc. staff)**

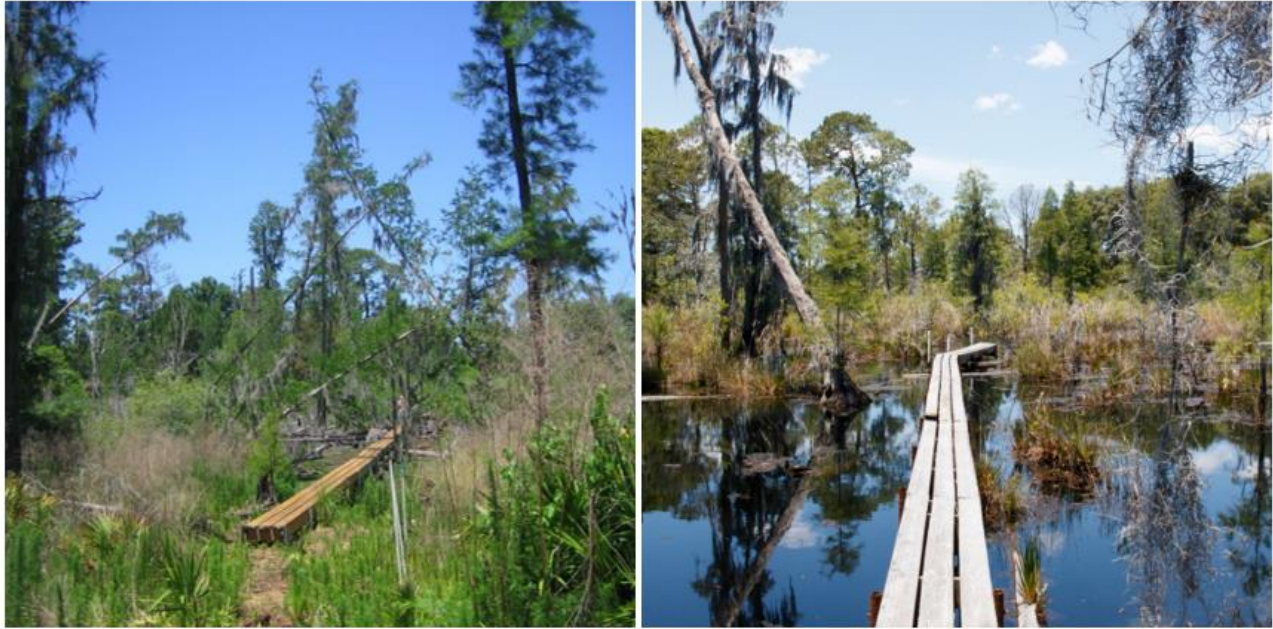
There is no better example of environmental improvement or recovery than what has occurred at wetland S-044 in the center of the Starkey Wellfield. This wetland was given the name “Widowmaker” due to the significant number of wetland trees that fell following extensive subsidence of the wetland bottom in the late 1980’s. The wetland trees began to lean and fall immediately after the subsidence occurred and the tree canopy was almost completely gone by 1994; this was a dangerous site for ecological monitoring during that time period. A series of fires in the wetland further reduced the number of wetland trees. This wetland is now approximately seven feet deep following the collapse of the bottom sediments, an atypical depth for an isolated cypress wetland. Figure 3.78 contains two photographs of this wetland taken in May 2006 and May 2016, both at the end of the eight-month dry season. The photograph from 2006 shows the wetland in its typical dry condition before the dramatic reduction in pumping at the Starkey Wellfield in December 2007. Before this time, the wetland seldom had standing water but following the pumping reduction and a return to more normal rainfall conditions, the wetland now has standing water throughout

the year. Since 2010, this wetland has not dried out and the water level reaches the normal pool elevation during most summer rainy seasons and is a dramatic example of environmental recovery.

**Figure 3.78: Starkey Wellfield Wetland S-044; photos from May 2006 and May 2016, Water Level Improvement. Early (Photo provided courtesy of GPI, Inc. staff)**

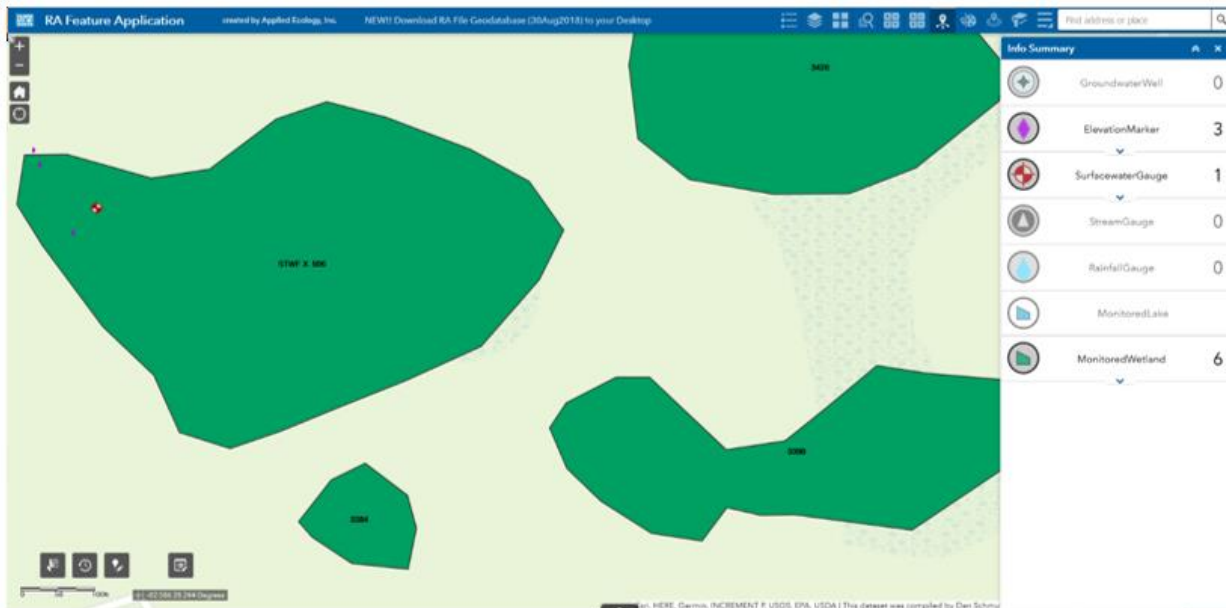
Area summary tools count the number of monitored lakes or wetlands in the current map extent (Figure 7.4), and the Info Summary tool provides that data for groundwater wells, elevation markers, surface water gauges, and stream and rainfall gauges (Figure 7.5). The NearMe tool calculates the number of surface water gauges, groundwater wells, production wells, stream gauges, and monitored wetlands within a set distance of a selected location (Figure 7.6). More involved analyses can also be performed, including locating individual features, creating buffers, extracting data, interpolating between data, and summarizing data within or near a selected location (Figure 7.7). A comment table and the draw tool allow users to highlight and comment on attributes, creating a way to flag and fix errors as data continue to be added and updated after the completion of the Recovery Assessment Plan.

**Figure 7.5: Image of the same area as in Figure 7.4 but using the Info Summary Tool to characterize the number of various monitoring sites and devices in the viewing area (which includes behind the info summary table).**

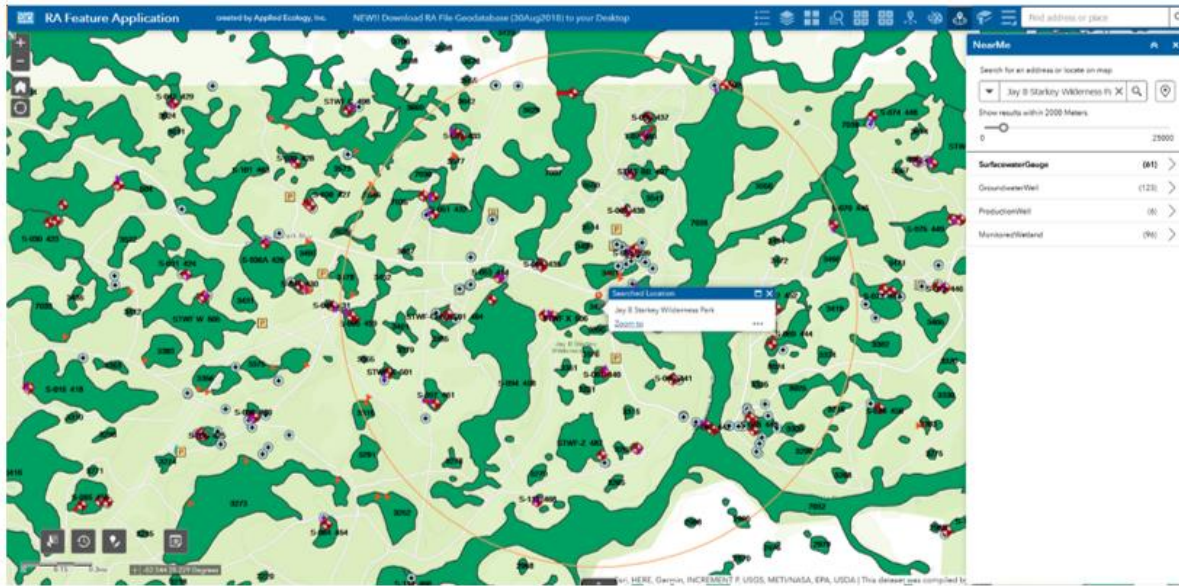
**Figure 7.6: Example Using the NearMe Tool in the RAGIS Application, Calculating the Number of Gages and Wells Around a Wetland Site on J.B. Starkey Wellfield.**

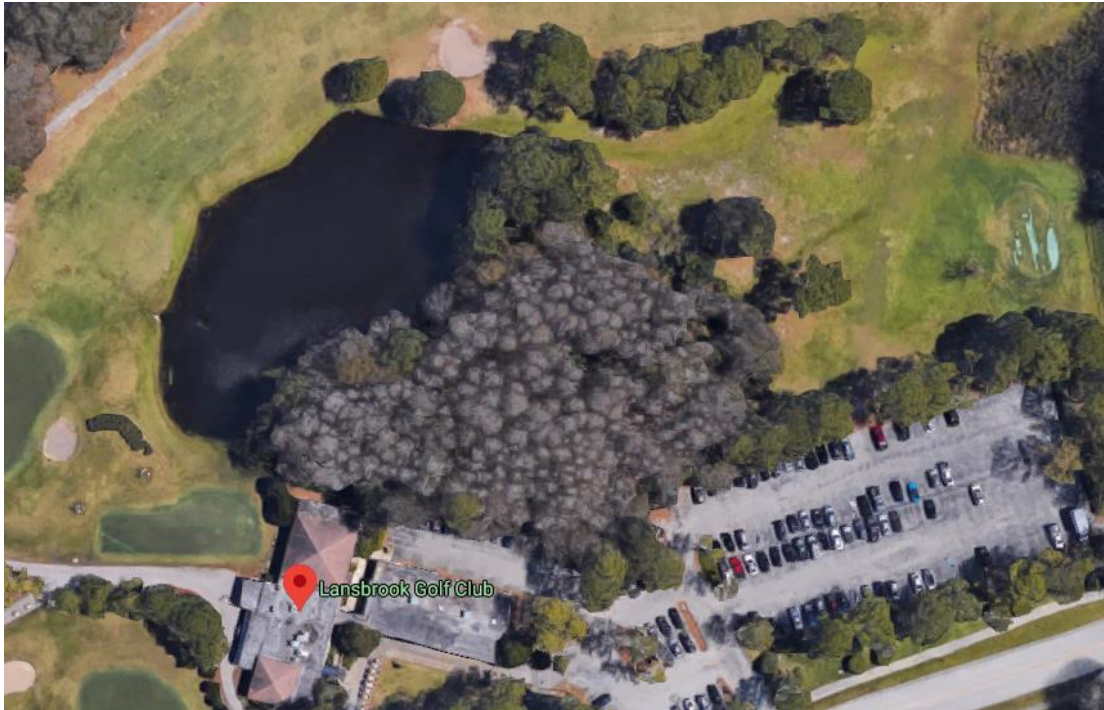
**ELW SW272716:** Wetland ELW SW272716 is a shallow, isolated cypress wetland located at the Lansbrook Golf Course south of the Eldridge-Wilde Wellfield and occupies a location between the clubhouse parking lot and an excavated golf course pond (Figure 9.5). Prior to construction of the golf course, the area of the excavated pond was upland pasture, as shown in the 1970s-era aerial photograph (Figure 9.6). A field reconnaissance on February 21, 2017 found that the excavated pond adjacent to the wetland exists at a lower elevation such that water levels in the pond are lower than the wetland, and often below the wetland bottom, which promotes seepage out of the sides and bottom of the wetland. The wetland may receive some stormwater input from the adjacent parking lot, but the edge of the wetland has been excavated to promote surface flow out of the wetland and down toward the pond, preventing the site from staging up to its normal pool elevation during periods of high rainfall.

**Figure 9.5: Location of Site ELW-SW272716 Adjacent to the Lansbrook Golf Course Parking Lot**

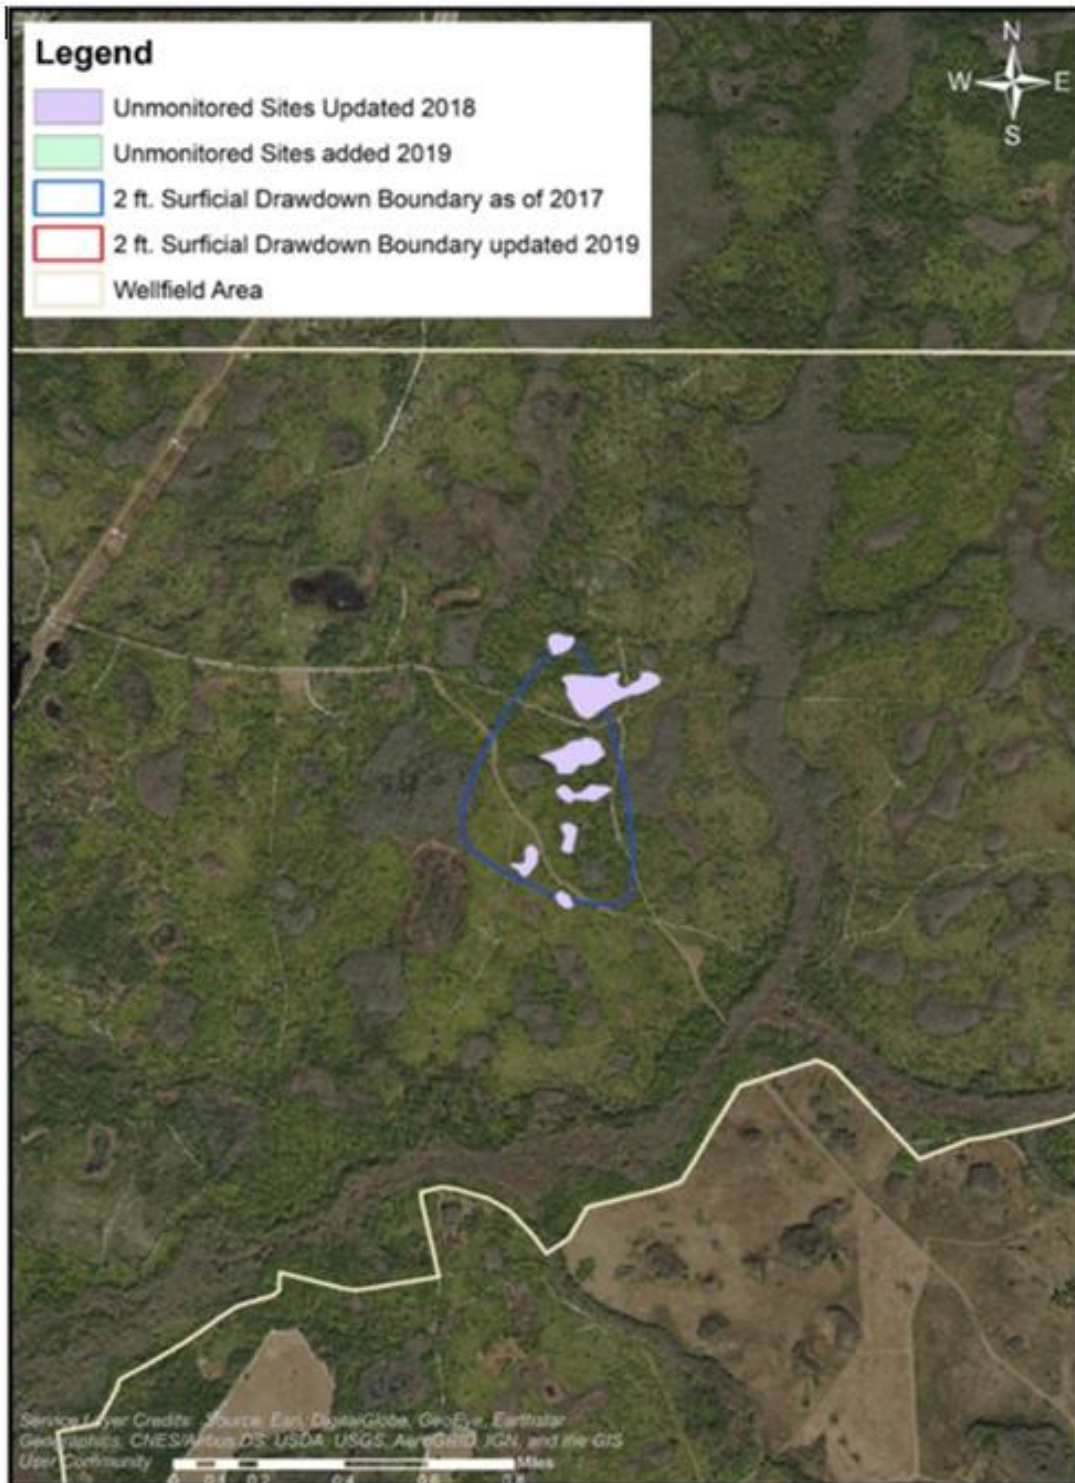
**Figure 10.8: Map Comparing the 749 Wetland Sites**

Figure 10.8: Map comparing the 749 wetland sites updated in the 2017 analysis to the 845 finalized from the 2019 pumping analysis, along with the 2017 updated AOI compared with the area developed from 2017 and 2018 pumping for the J.B. Starkey Wellfield. The new AOI is represented by the outermost extent of both the red and blue contours.

There is a relatively small Area of Investigation defined at the Starkey Wellfield as described in Section 5.3. Seven unmonitored wetlands are either contained within or intersect this area (Figure 10.8) and the final qualitative recovery assessments for these wetlands are depicted in Figure 10.22. Six of the seven wetlands are binned as having a high degree of certainty of wetland health and one unmonitored wetland (#3461) as having a low degree of certainty of wetland health. Of the criteria tested in the unmonitored wetland study performed by Tampa Bay Water (described in Chapter 10), Wetland 3461 met the criteria for modeled increase in normal pool offset between the pre and post-cutback periods but did not meet any of the other assessment criteria. These results generally match the high degree of recovery documented for the monitored wetlands at the Starkey Wellfield.

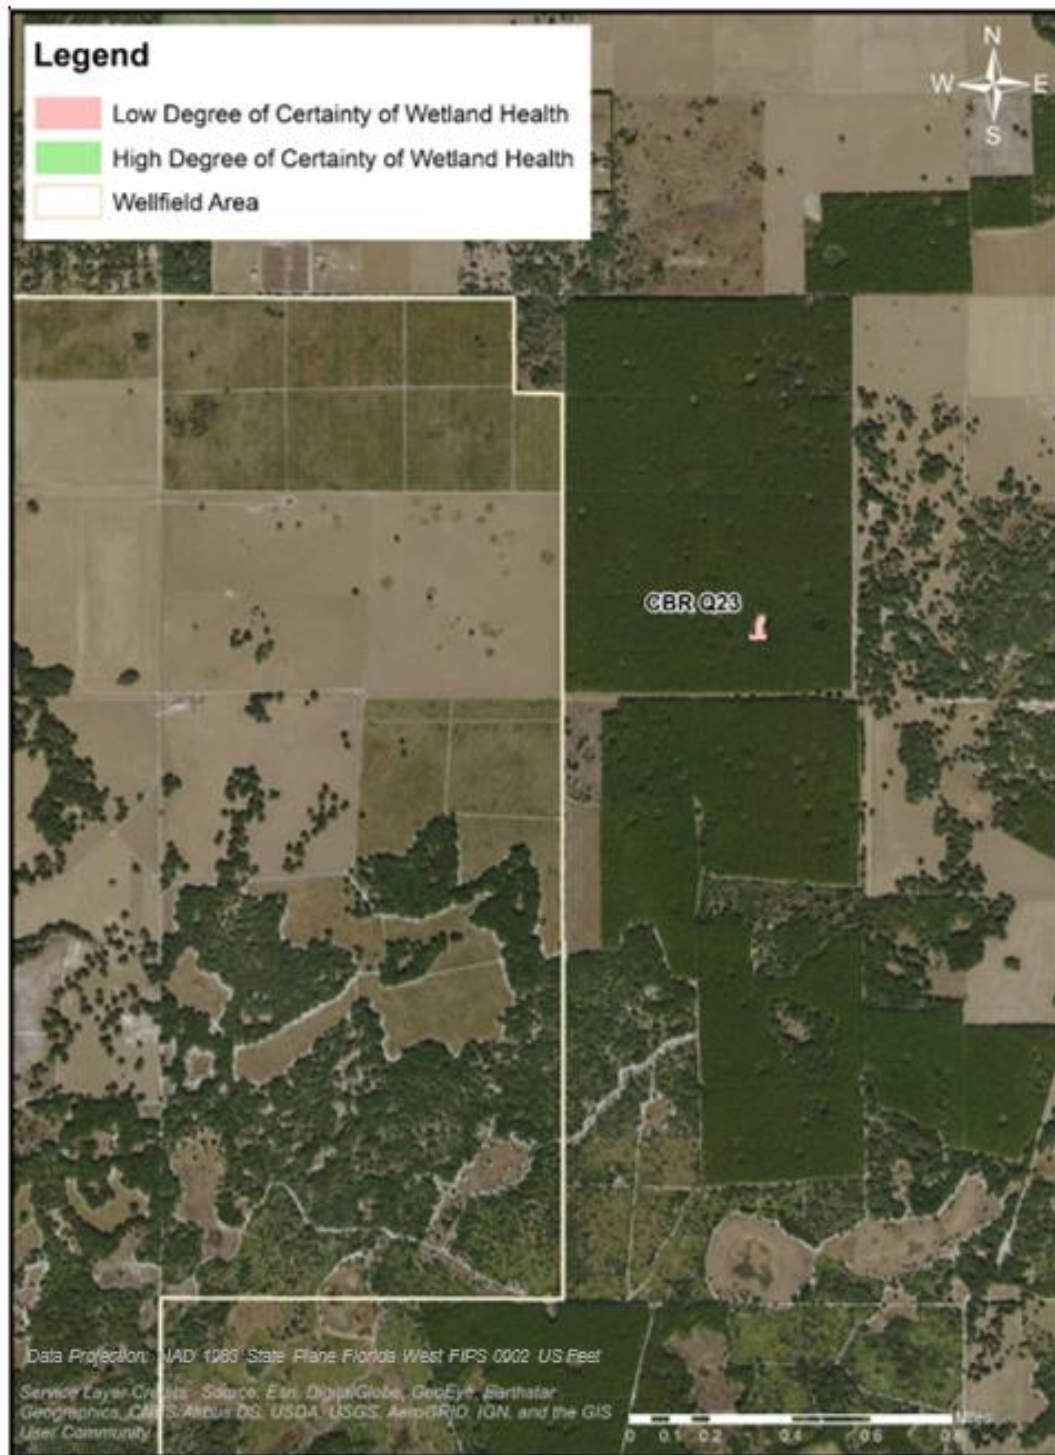
None of the xeric wetlands on this list could be assessed using the new isolated xeric wetland metric because they had very limited water level data records and the Random Forest assessment was not updated using this new xeric metric for reasons previously discussed. For this final assessment of the 27 formerly-monitored sites, the xeric sites on this list were assessed using the original xeric wetland metric based on the results of the Random Forest analysis. Two of the formerly-monitored wetlands were outside of the range of Lee and Fouad's analyses (HSW Engineering, 2018); therefore, they have been given a designation of N/A for the median depth to Upper Floridan Aquifer criterion. The data at these 27 sites were assessed for each of the six criteria and the results for each criterion at each site is presented in Appendix 10.1 and in Table 10.1. These sites were assigned one of the two new bin names for unmonitored sites; 24 of the sites were assessed as having a "High Degree of Certainty of Wetland Health" and three of the sites were assessed as having a "Low Degree of Certainty of Wetland Health". The final site assessment results for these formerly-monitored (inactive) sites are also presented in map

**Figure 10.9: Map of the Inactive Sites near the Cross Bar Ranch Wellfield with Final Bin Designations**

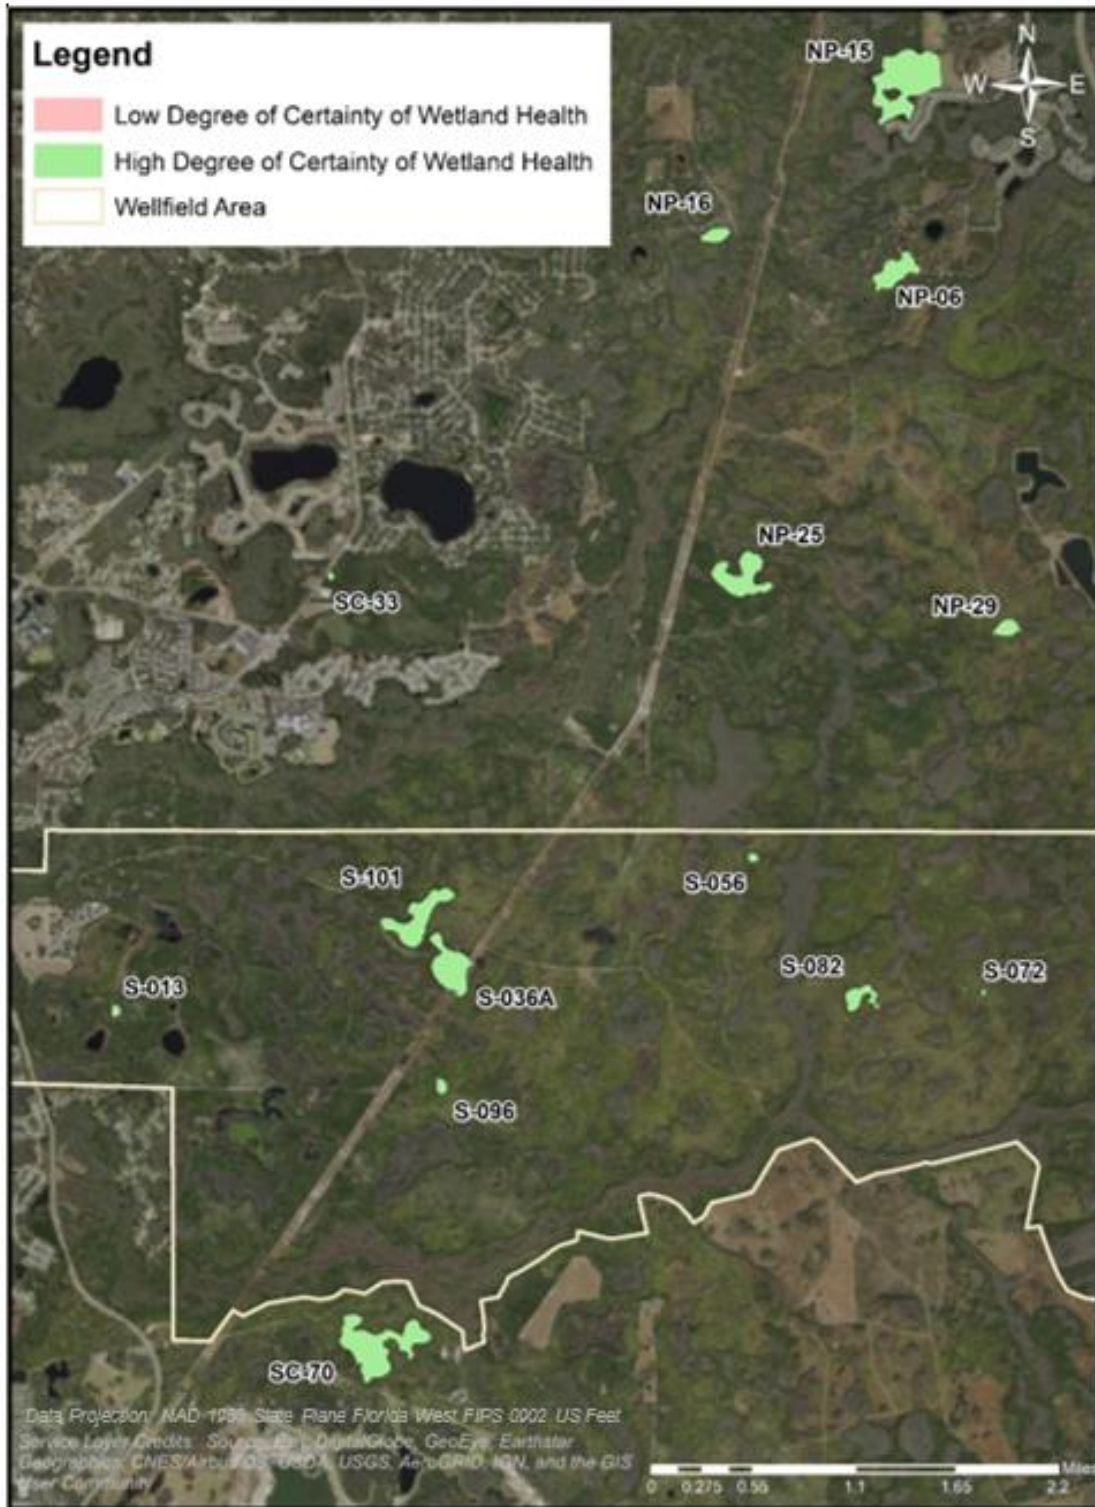
**Figure 10.11: Map of the Inactive Sites near the J.B. Starkey and North Pasco Wellfields with Final Bin Designations**

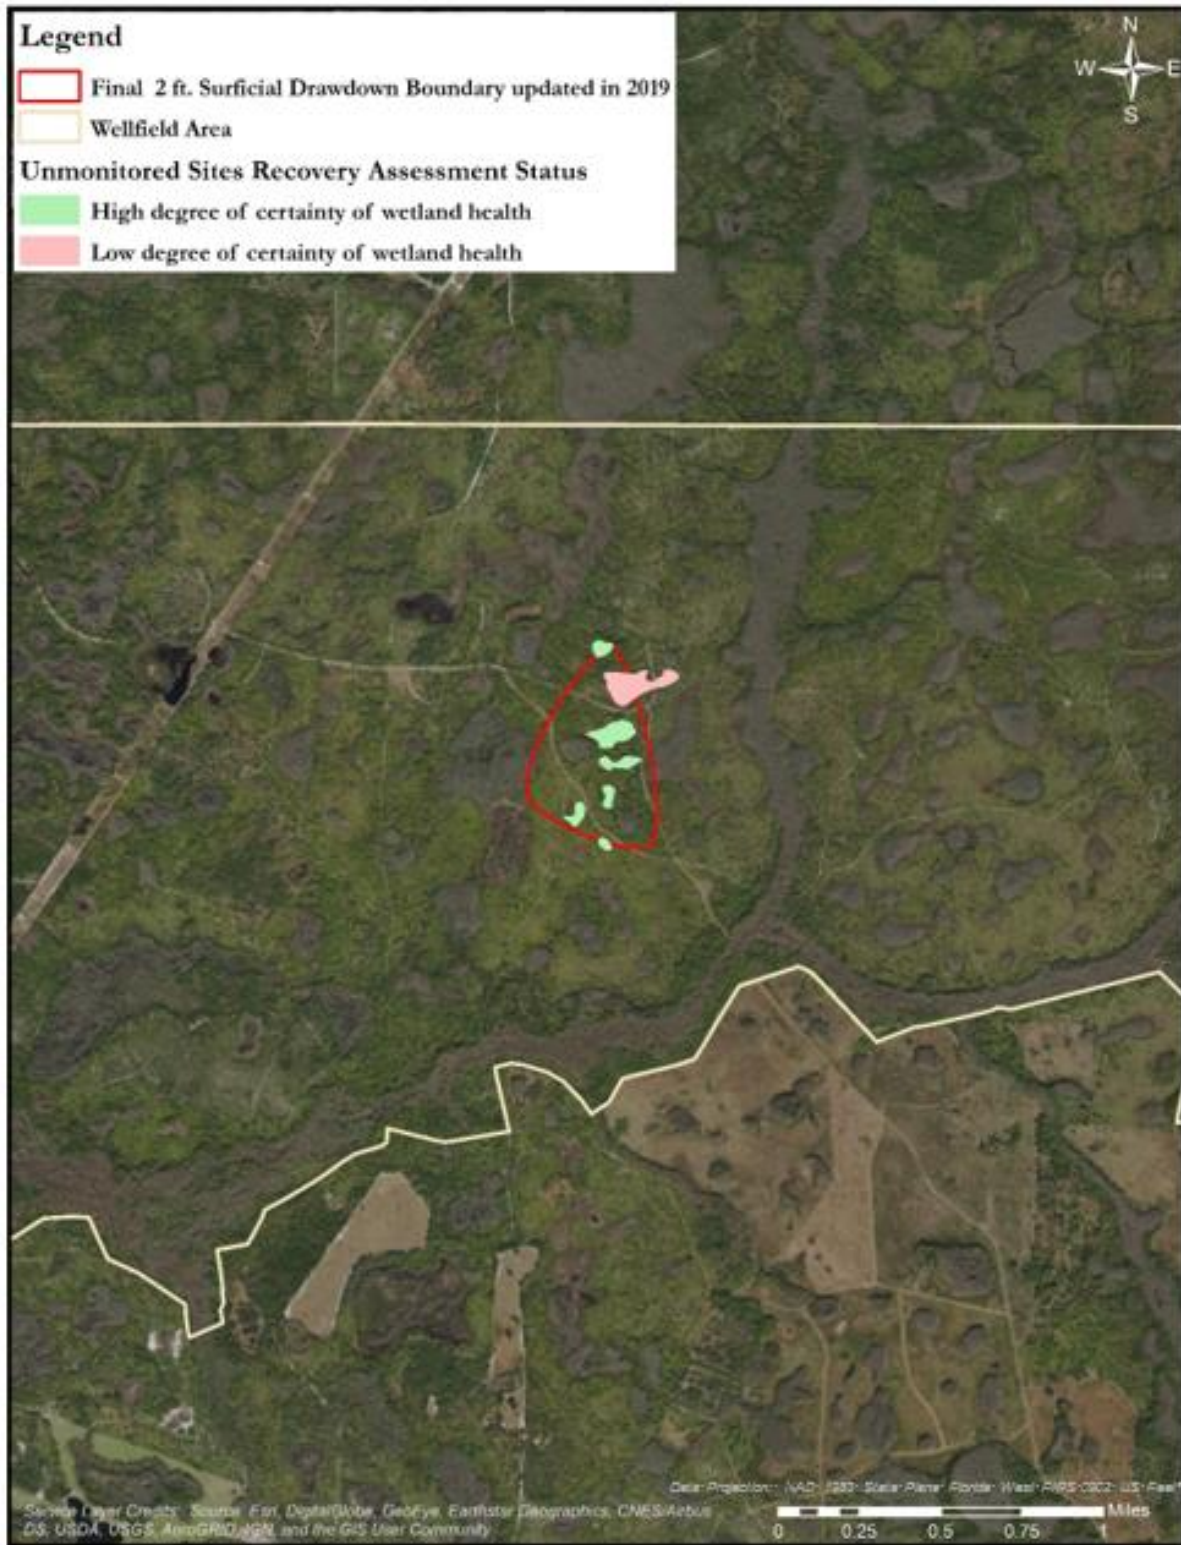
**Figure 10.22: Map of Final Unmonitored Site Bin Designations near the J.B. Starkey Wellfield**

The final results of the unmonitored site assessment indicate that 73% of these sites are predicted to have a high degree of certainty of wetland health based on the weight-of-evidence approach. It is important to note that the results of this qualitative assessment of wetland health matches well with the results of recovery at monitored sites within the wellfields. A total of 71% of monitored wetlands are designated as Never Impacted or Recovered/Meets Metric in this final assessment report. This validation of the final unmonitored site assessment method is logical since many of the spatial datasets used to assess unmonitored sites are based on data collected from monitored wetlands in the same vicinity as the unmonitored wetlands.

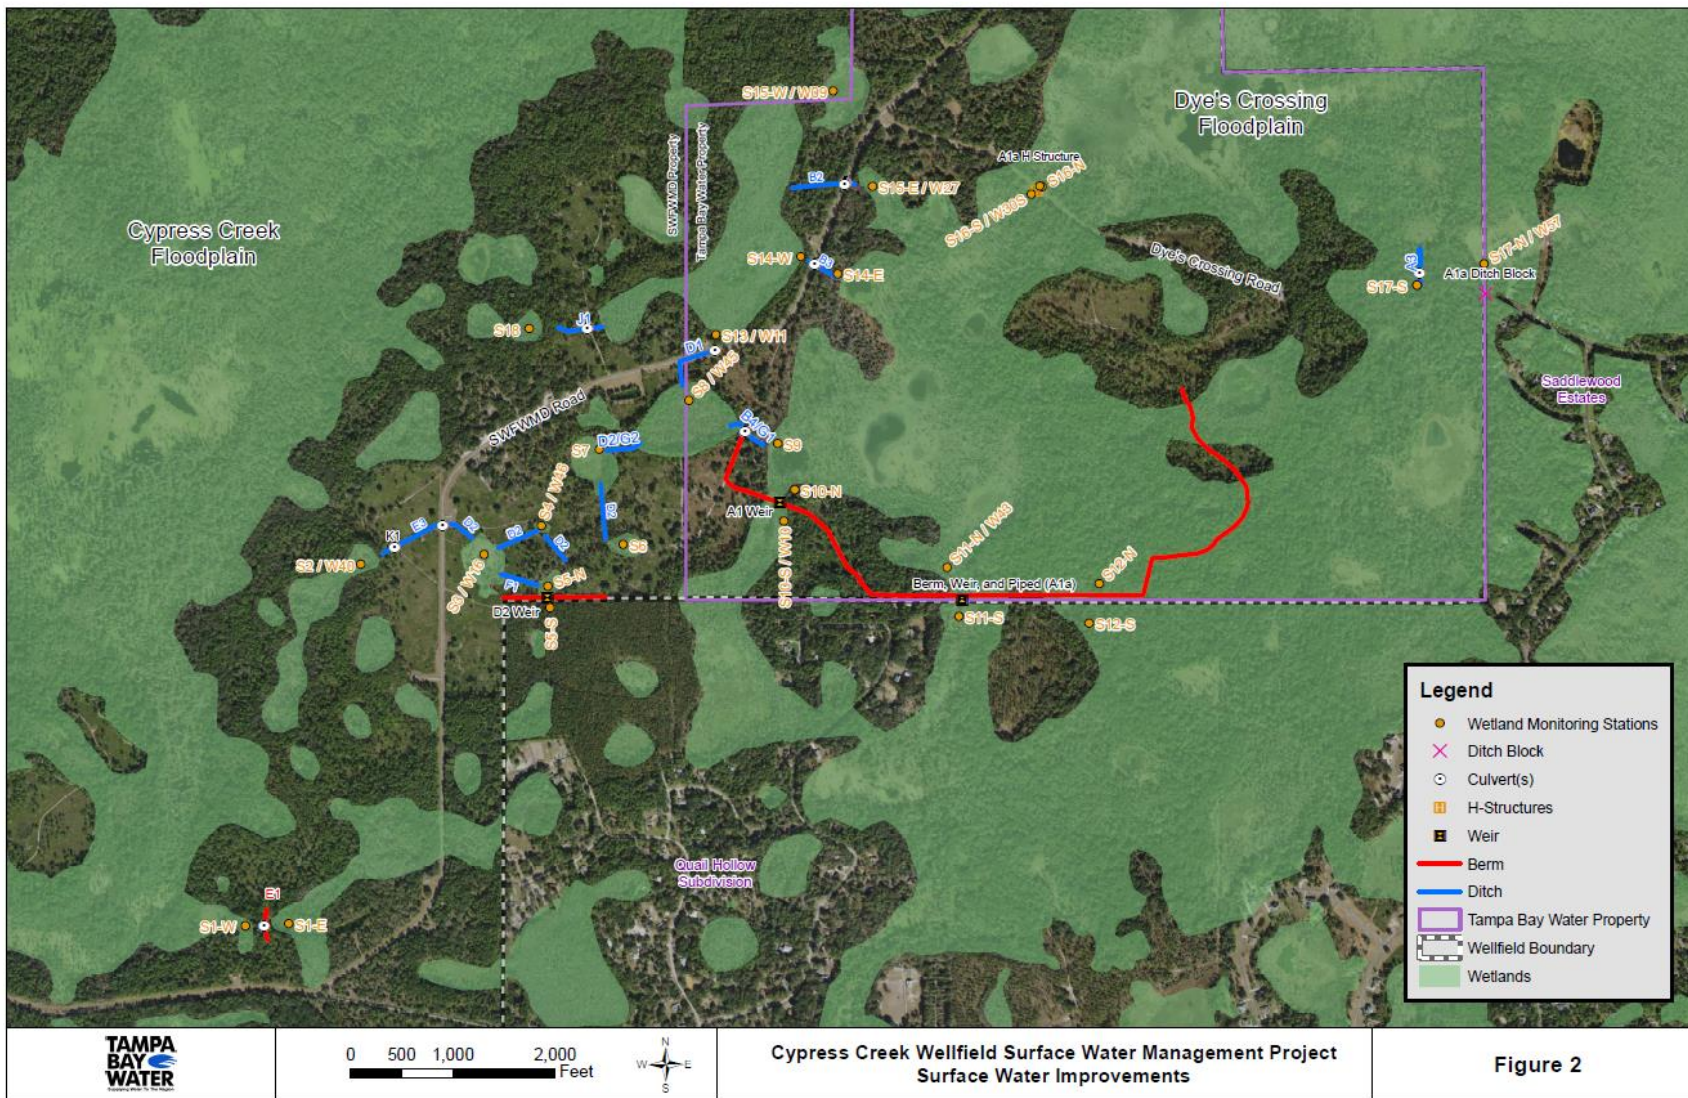
Figure 12.28: Cypress Creek Wellfield Surface Water Management Project Surface Water Improvements (from PSG 2019)

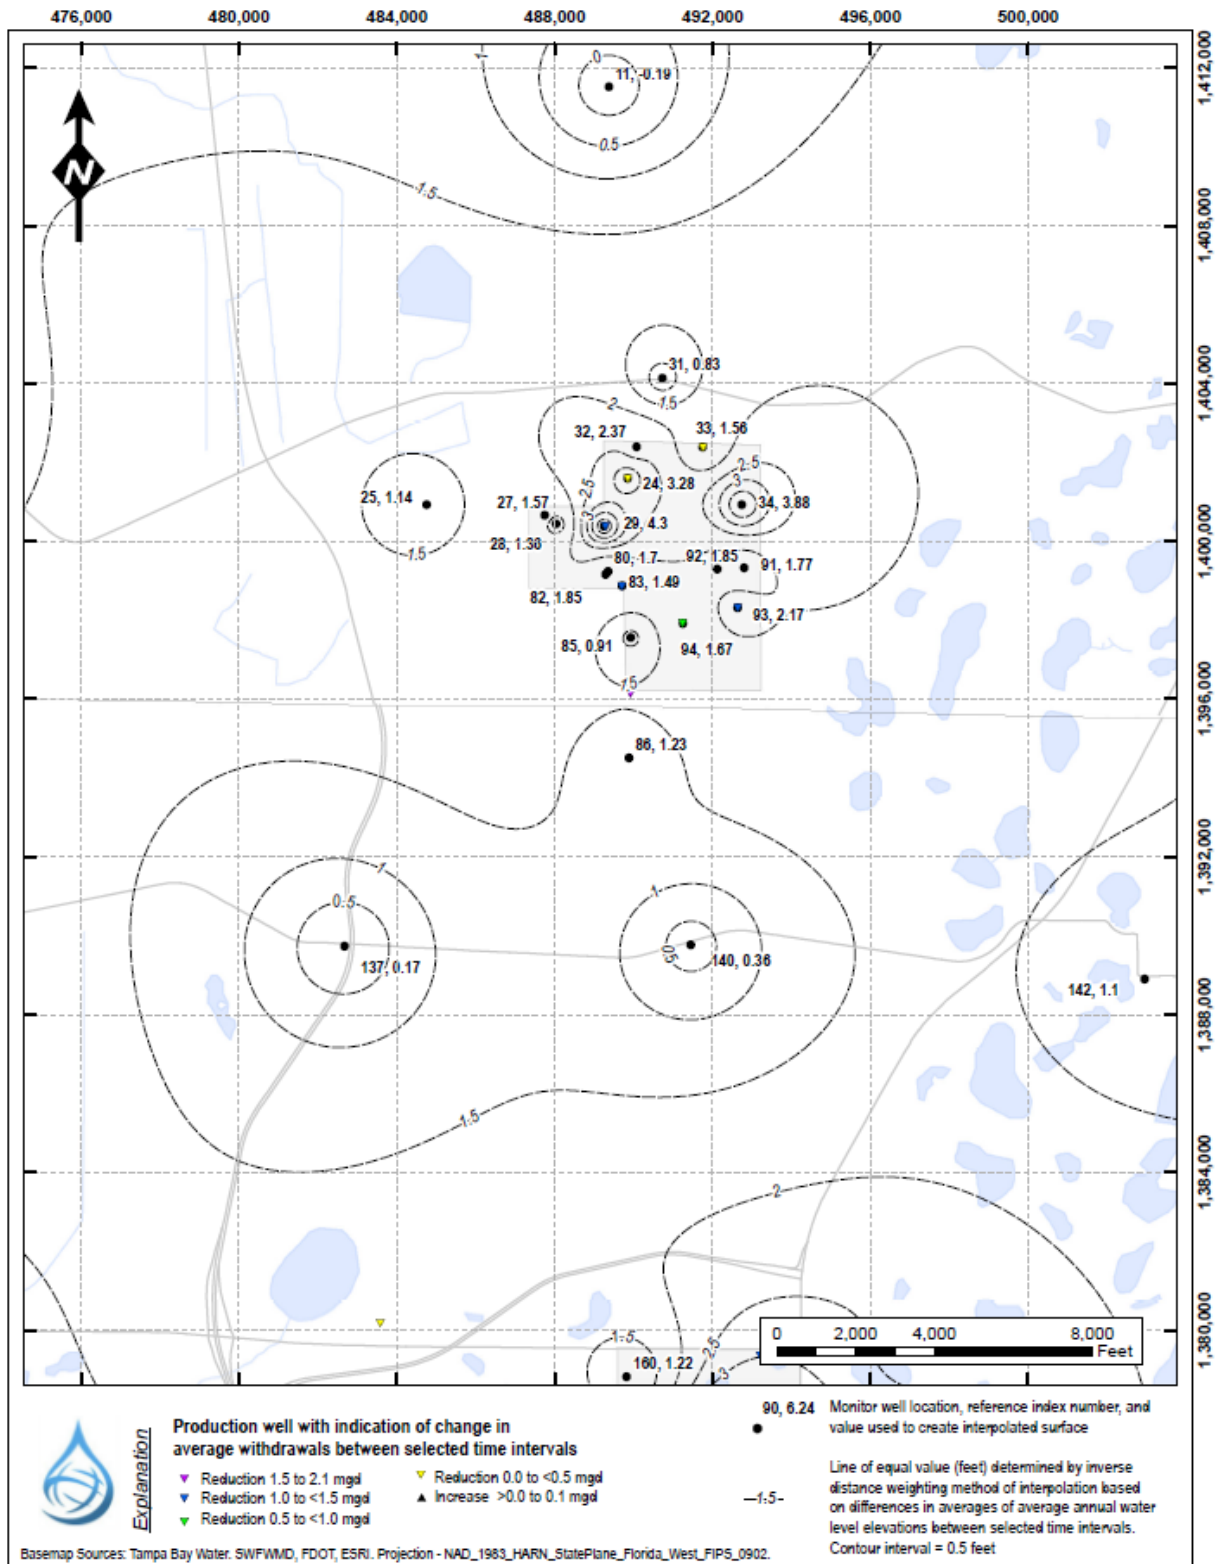
**Figure 12.44: Post-Cutback Recovery in the Surficial Aquifer at the South Pasco Wellfield (from Wise Consulting Group, 2016)**

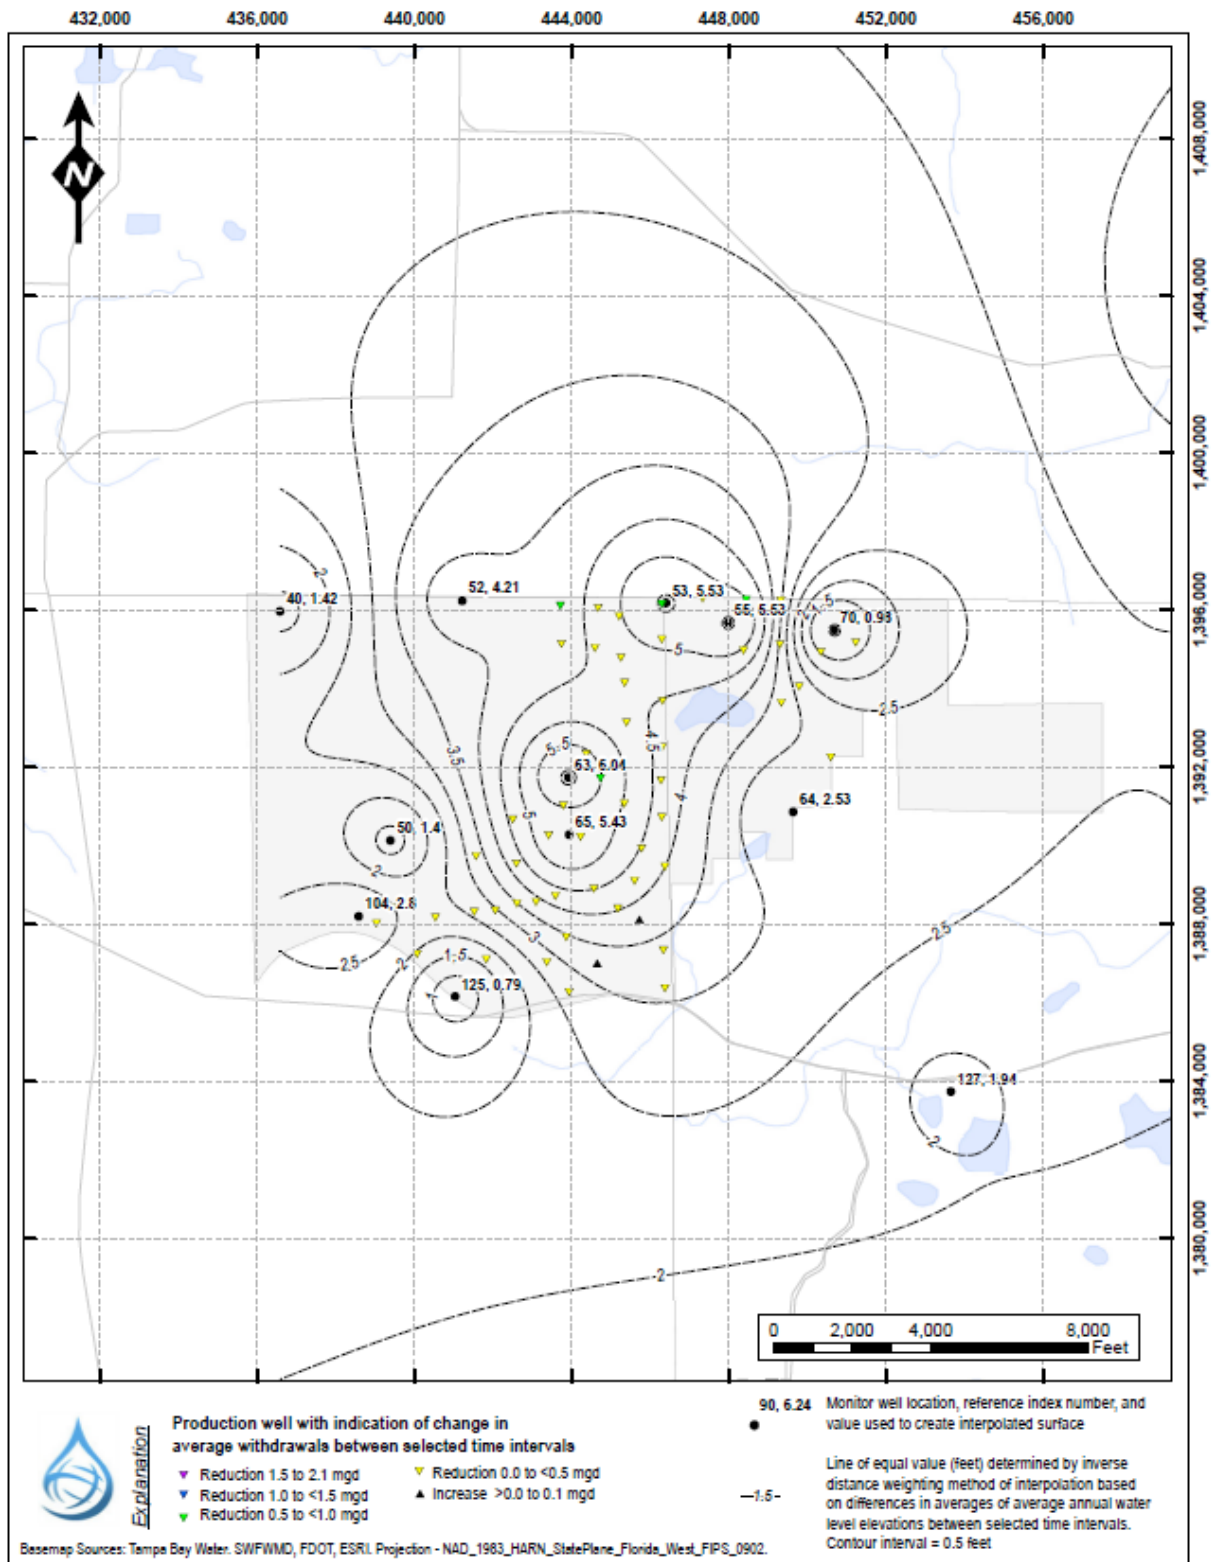
**Figure 12.53: Recovery in the Surficial Aquifer at the Eldridge-Wilde Wellfield Due to Pumping Reduction (from Wise Consulting Group, 2016d)**
