# Tampa Bay Water Recovery Assessment: Final Report of Findings

Final Report  
Consolidated Water Use Permit  
September 29, 2020

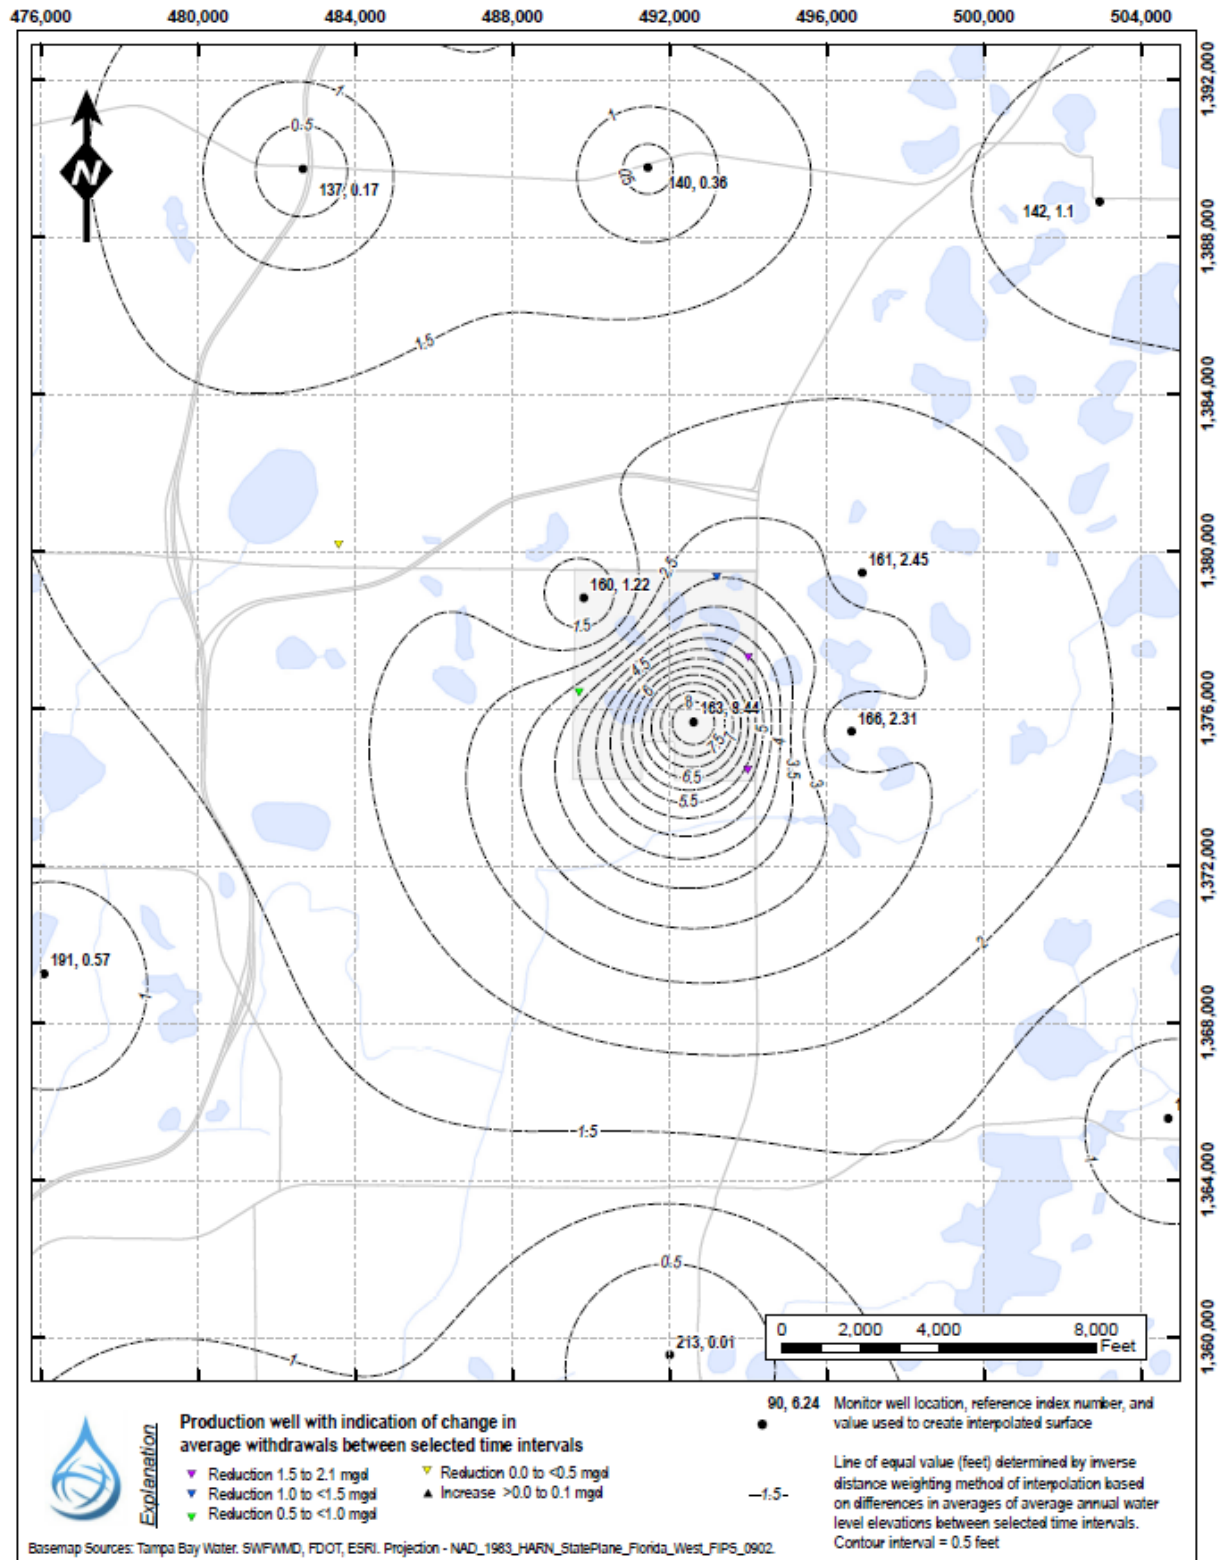
**Figure 12.63: Recovery in the Surficial Aquifer at the Section 21 Wellfield due to Pumping Reduction (from Wise Consulting Group, 2016d)**
